# 1993 Mercury Sable Wagon Alternator Replacement

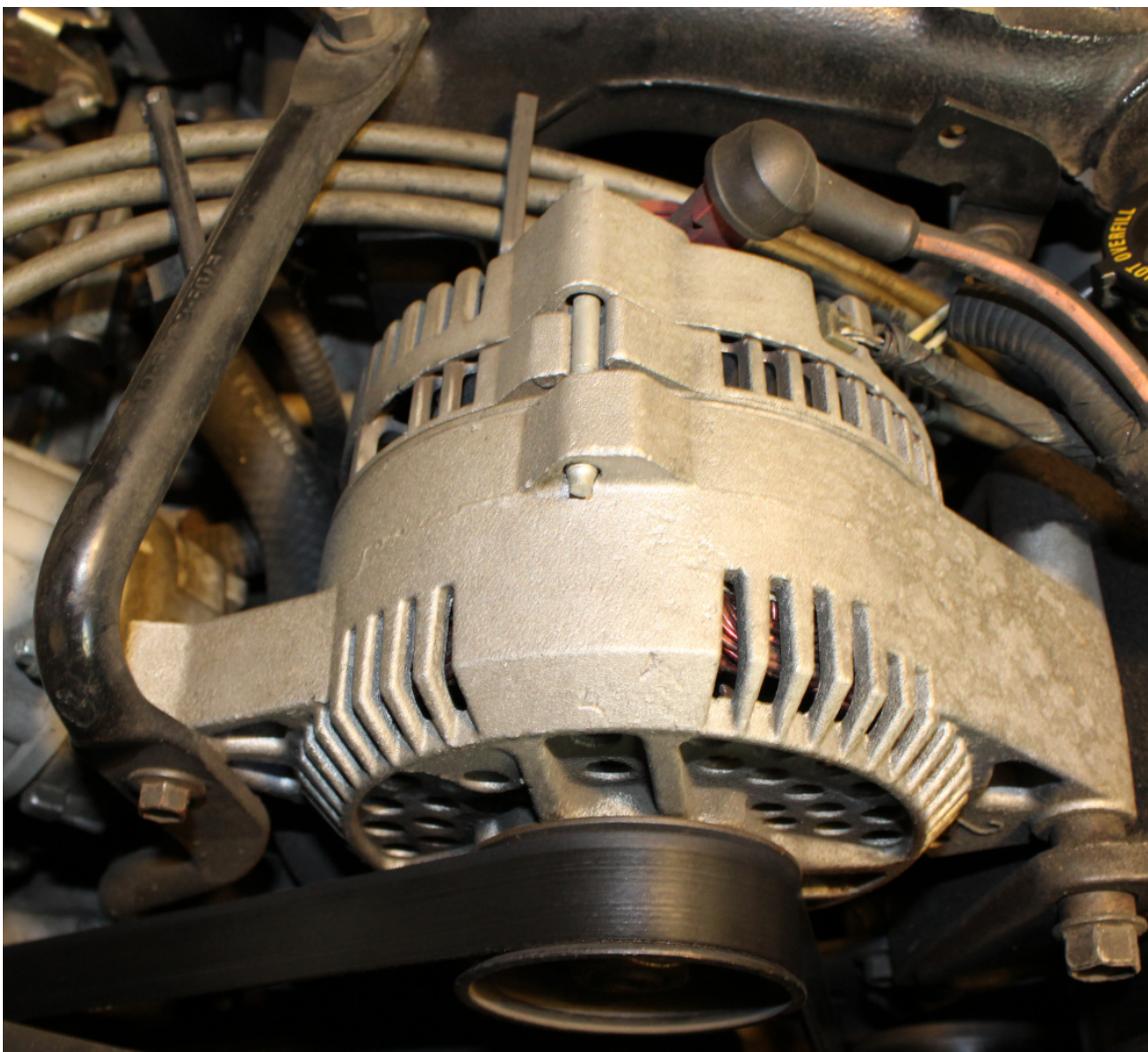
Drive Belt Link
