1993 Mercury Sable Wagon EGR Pressure Sensor Hose Repair

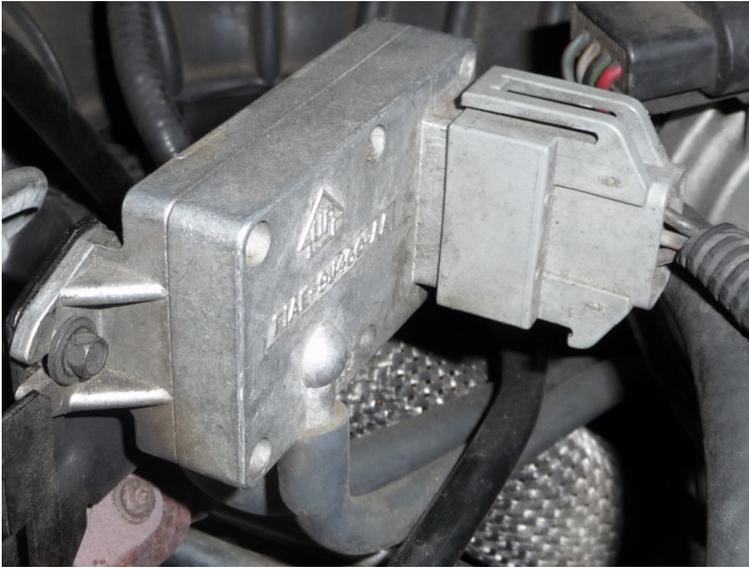
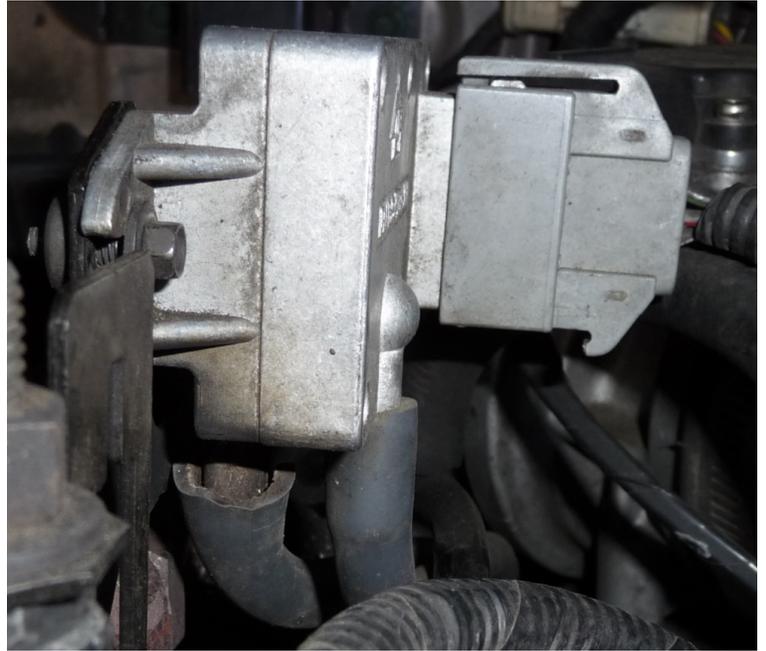
EGR (Exhaust Gas Recirculation) Pressure Sensor Hose Deteriorated (Left side hose)

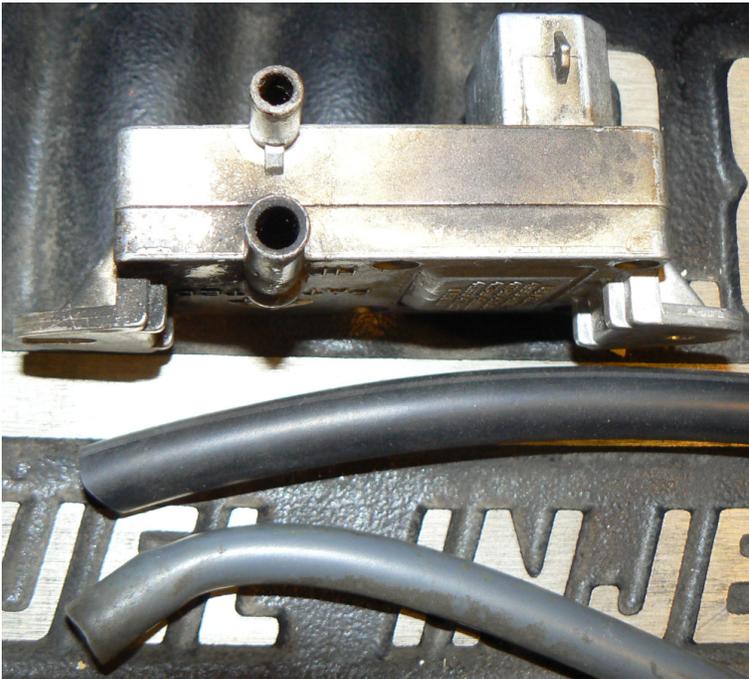
New (Black) Prepared

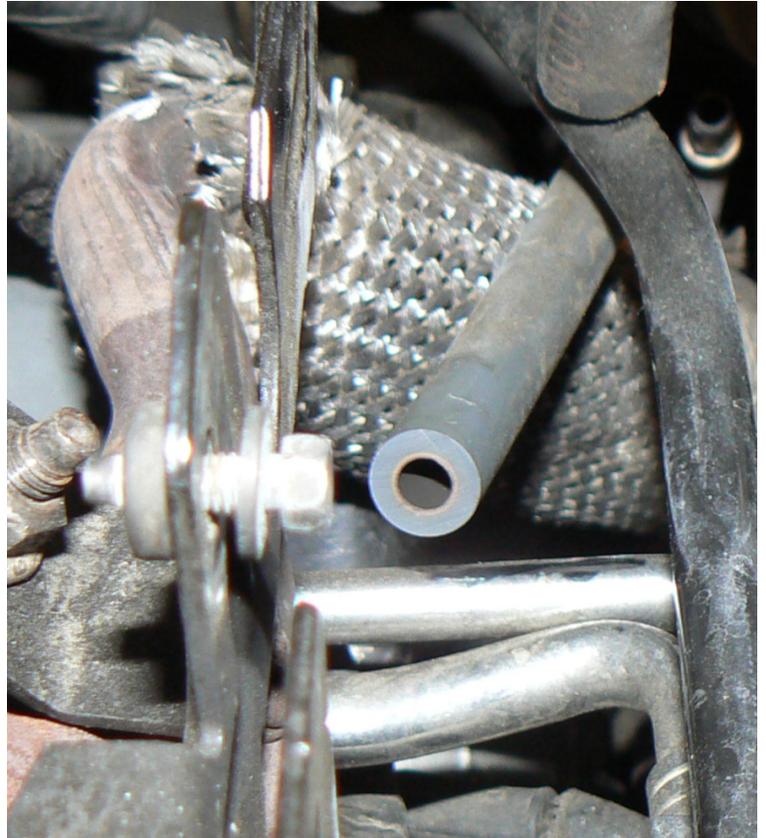
Cut out Deteriorated Portion of Old Hose

Disconnecting cracked hose (Gray) from another port was hard because of the limited space.

After cutting out cracked portion of old hose (Gray), new hose (Black) was jointed by epoxy putty to old hose.
