1993 Mercury Sable Wagon Engine Control Module Replacement

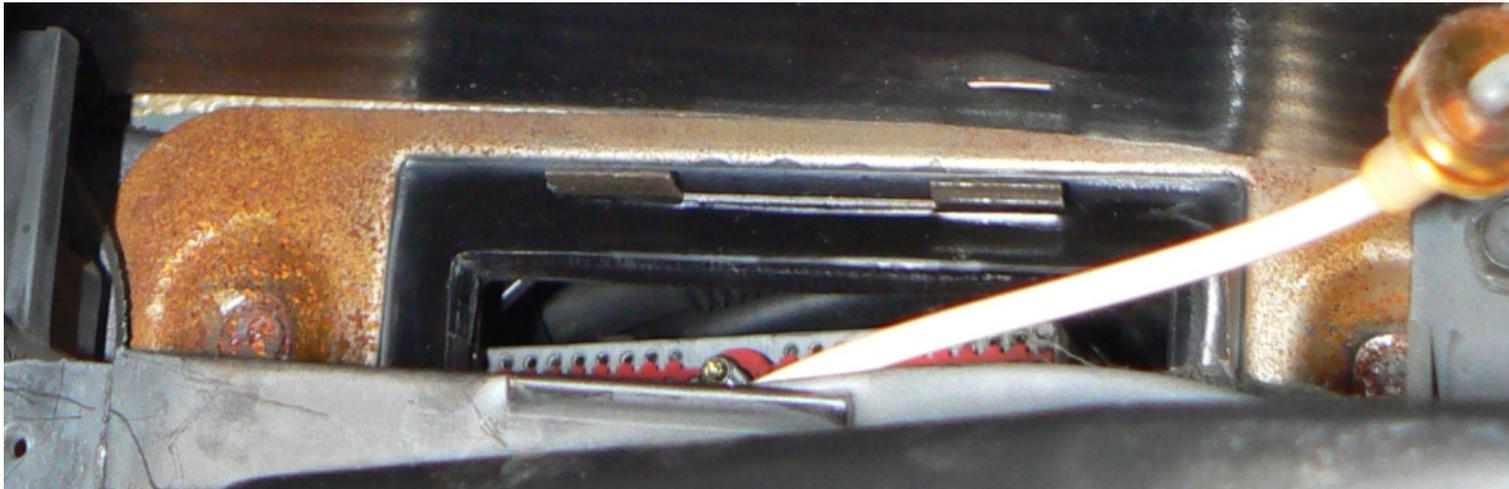
Old Engine Control Module Installed

OBDI scanner stopped the function occasionally because the serial data shift clock was not properly generated on ECM and provided to OBDI scanner.

Some strange behavior was observed when driving.

After replacing ECM, all the problems were gone.
