1993 Mercury Sable Wagon Front Strut Assembly Replacement

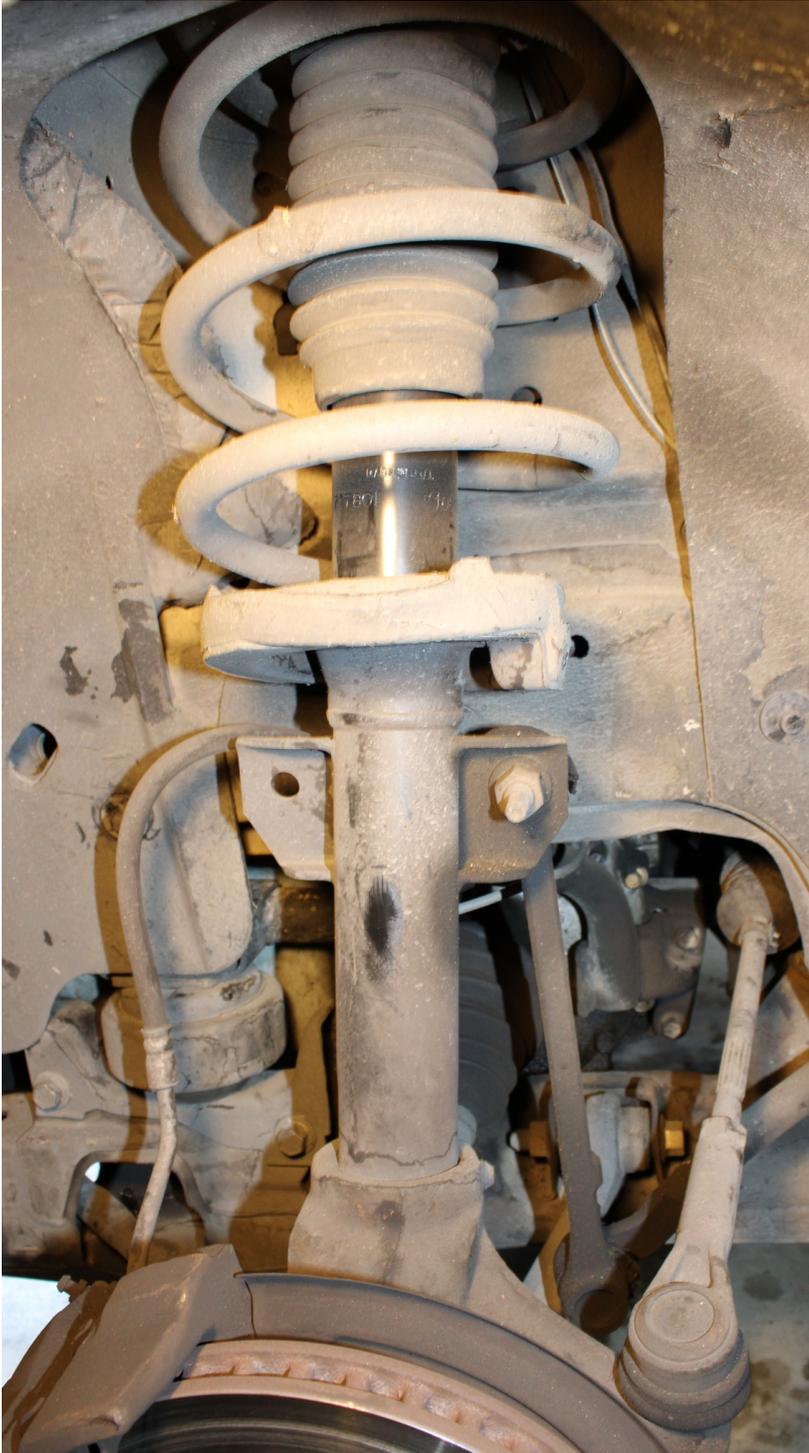
Before (Driver's side)

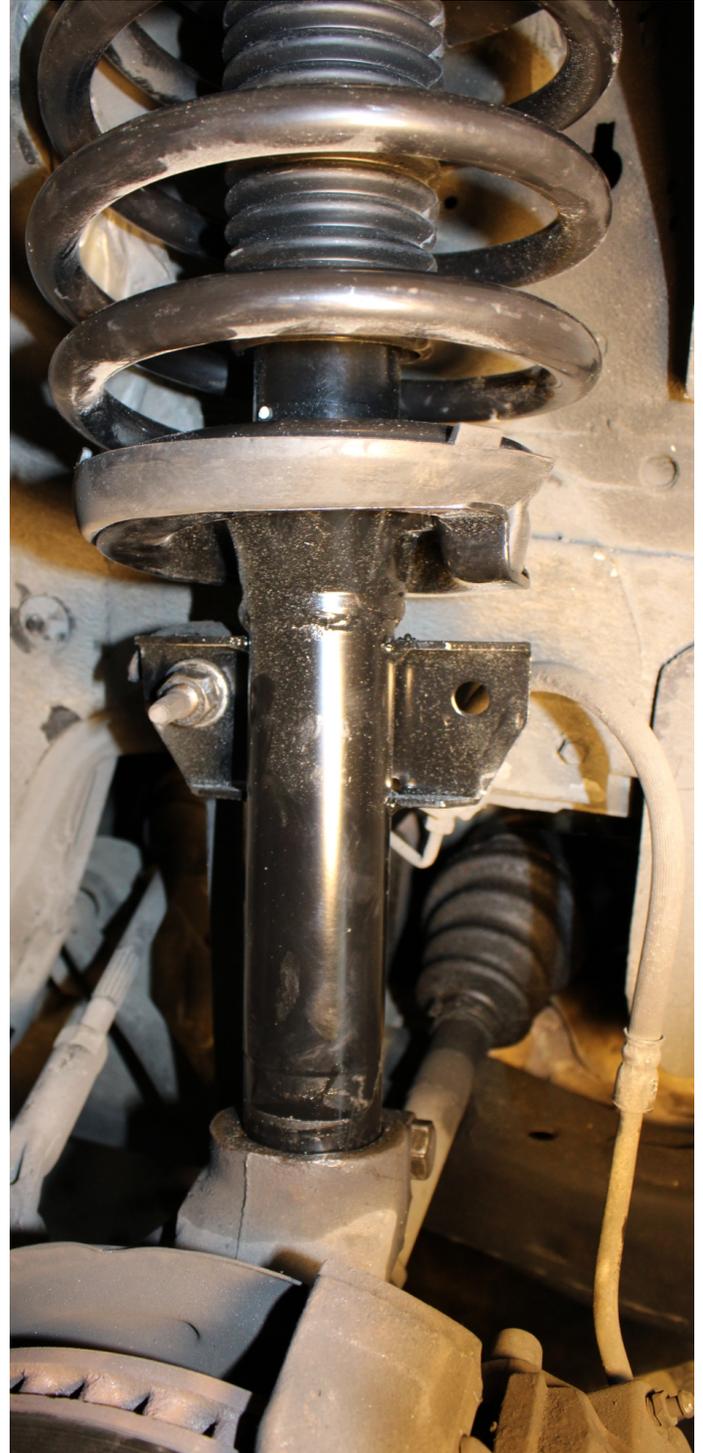
After (Passenger's side)
