# 1993 Mercury Sable Wagon Water Pump Replacement

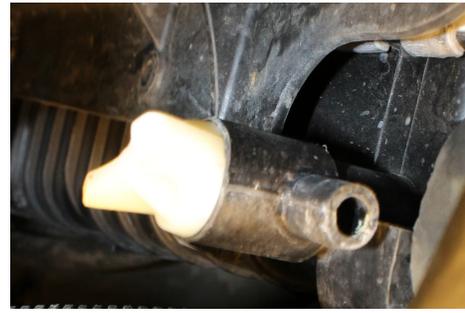
Draining Engine Coolant

The engine coolant must be drained first by opening drain plug under radiator.

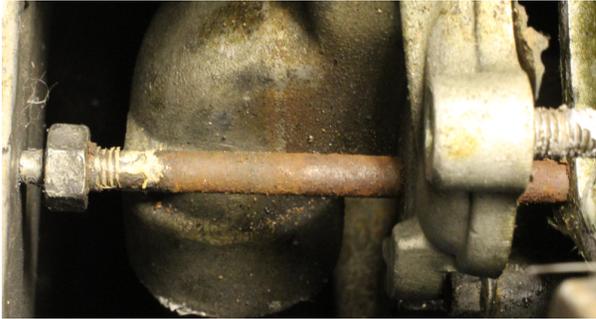
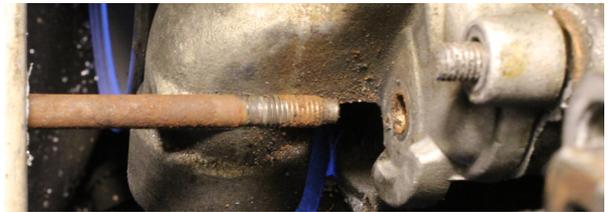
Nut of Water Pump Metal Inlet Tube Removed

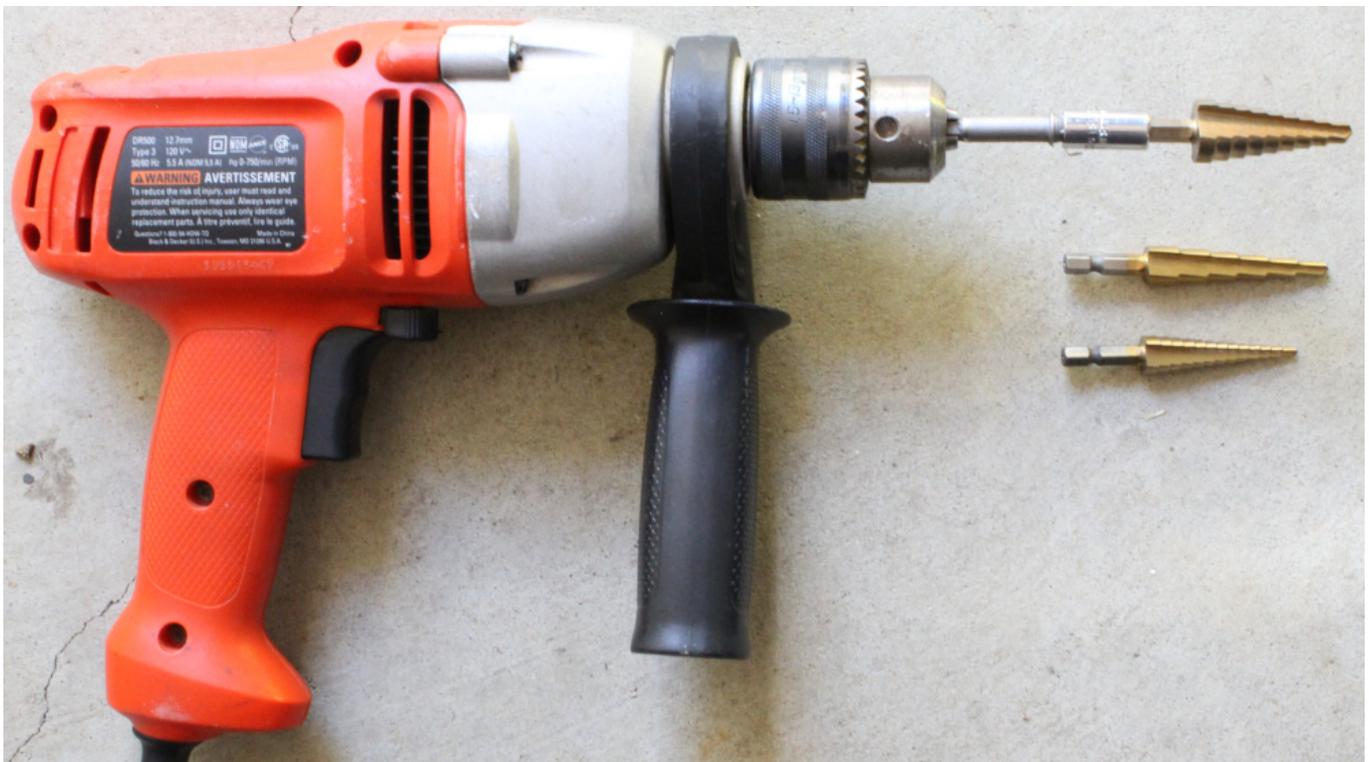
Long Nut-bar Removal Problem (Vehicle Design Flaw)

Passenger's side engine room panel made by metal prevented removing a long nut-bar.

To remove the long nut-bar, a hole was made on the metal panel by using special drill bits (Reamer).

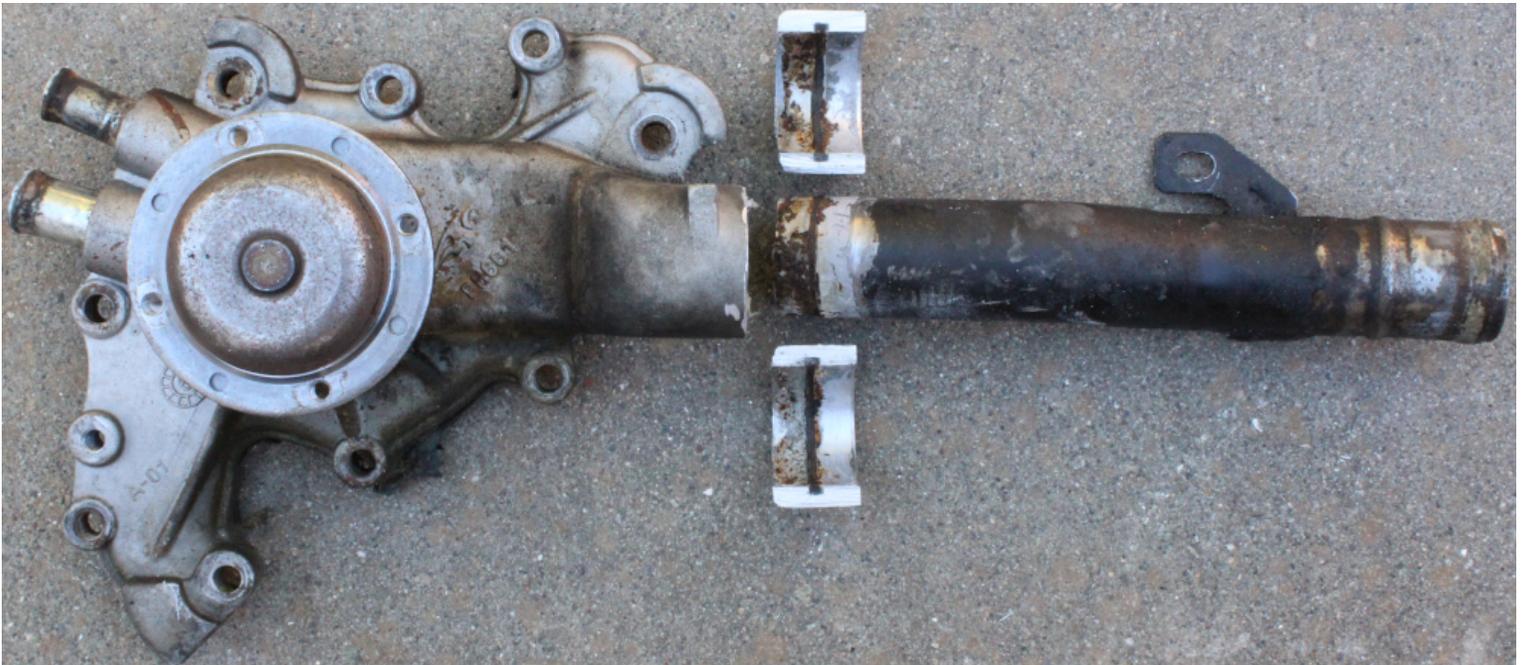
Old Water Pump with Inlet Tube Removed
