# 1995 Toyota Camry Oxygen Sensor (Bank2 Sensor1 (Upstream)) Replacement

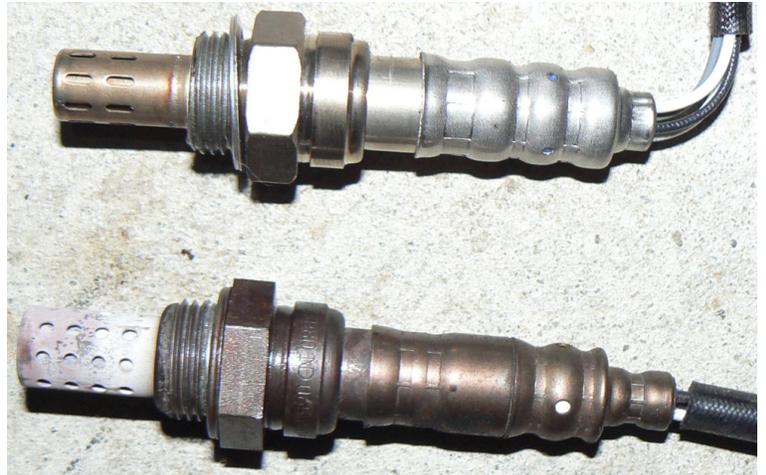
New (Top; After-market) & Old (Bottom; Genuine) Oxygen Sensor

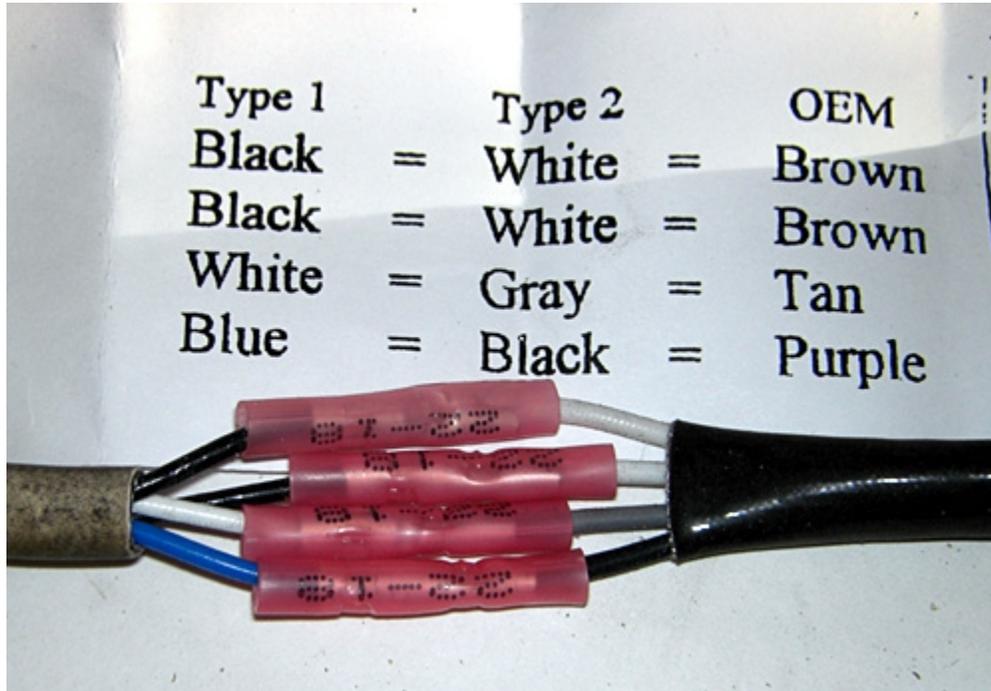
- (1) The connector pins do not go through the automobile side receptor due to the connector incompatibility.
- (2) Sometimes, there is no connector attached expecting a genuine connector is attached.
- (3) The color code of the four signal lines is different to exhibit that this is an after-market product, not genuine.

Type 1 (Left) : Genuine  
Type 2 (Right) : After-market

Therefore, it is recommended that the original connector must be cut out from the genuine oxygen sensor and connected to the after-market oxygen sensor using butt splicing (See below).
