Repair Patio Roof

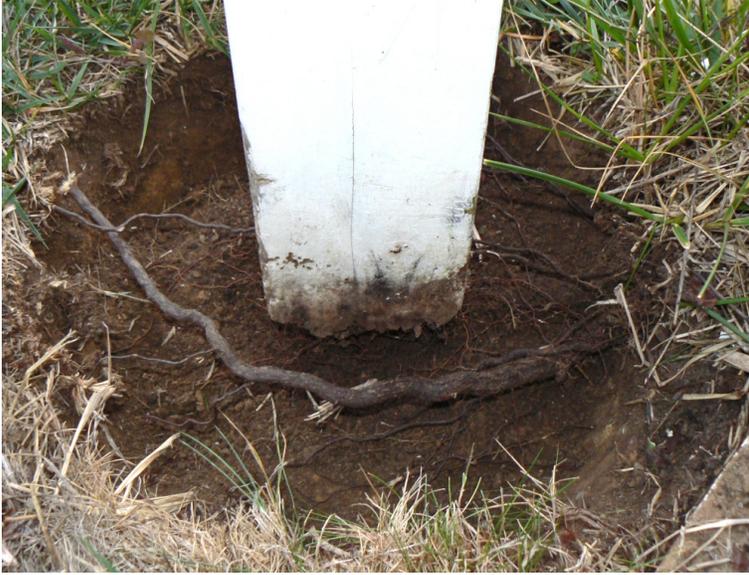
Patio Roof Pillar

Cause was Found

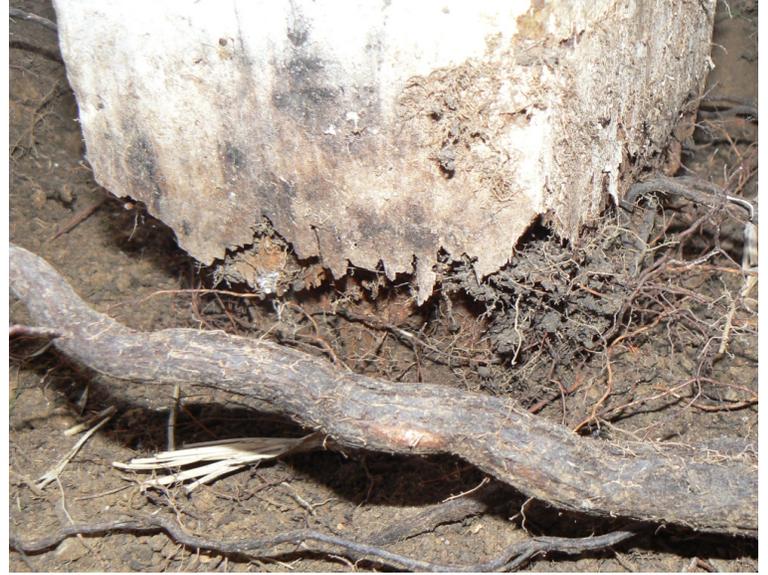
Dacaying

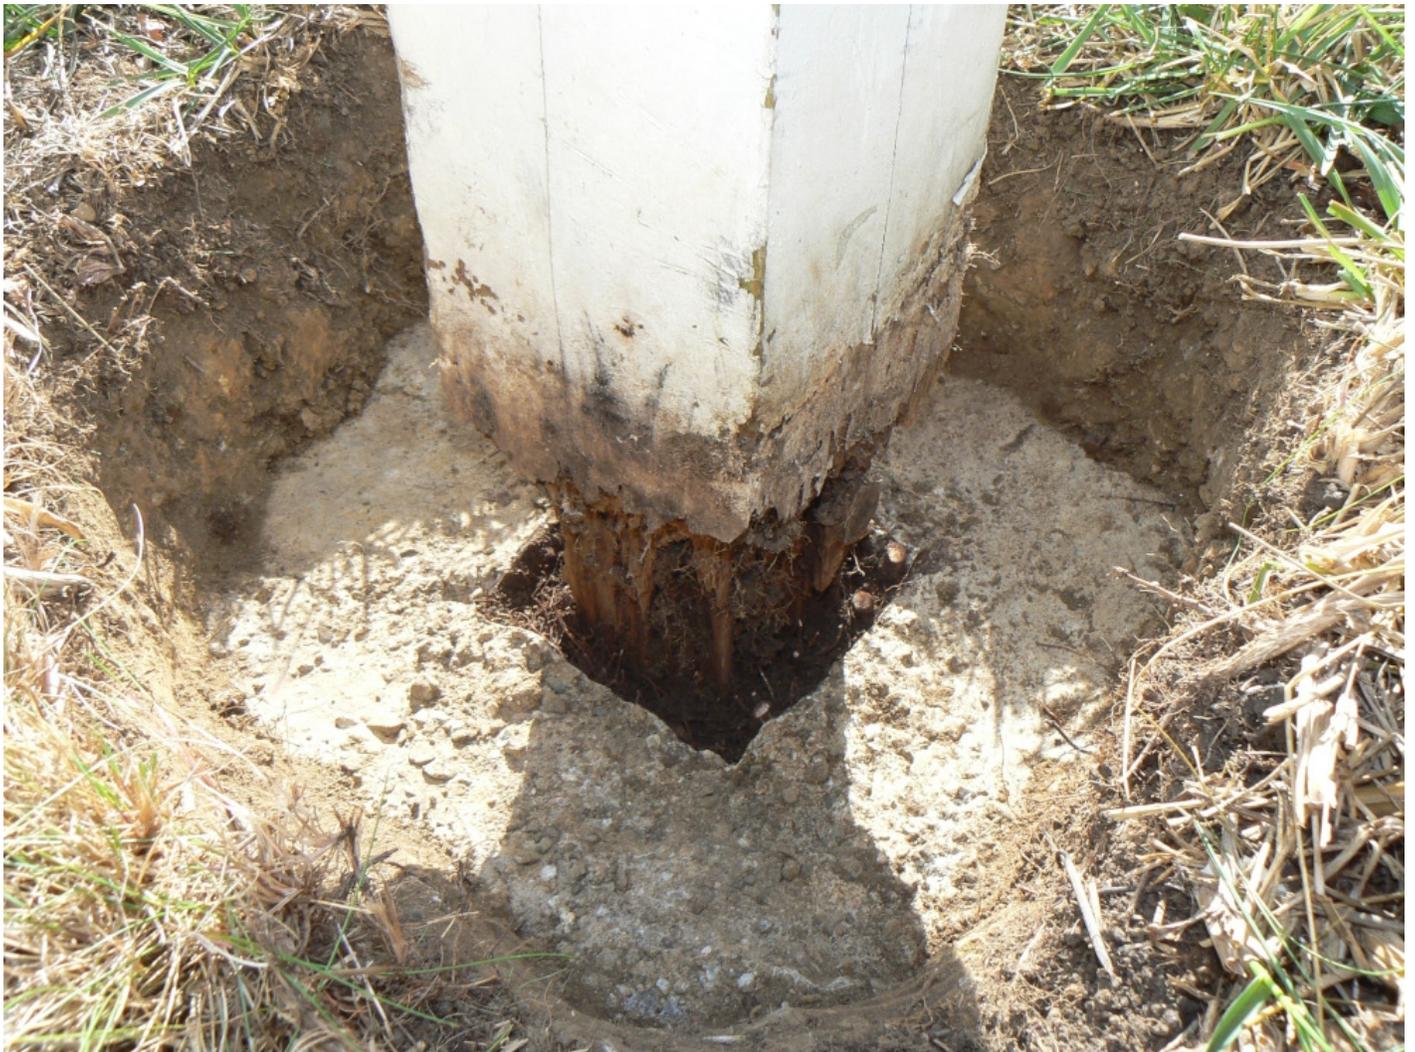
Decayed a Half & Thinned

One of decaying pillars was the cause of swaying patio roof. Less workmanship gardener placed lawn and sprinkler close to existing patio pillar without paying any attention. The pillar got too much water and decayed.

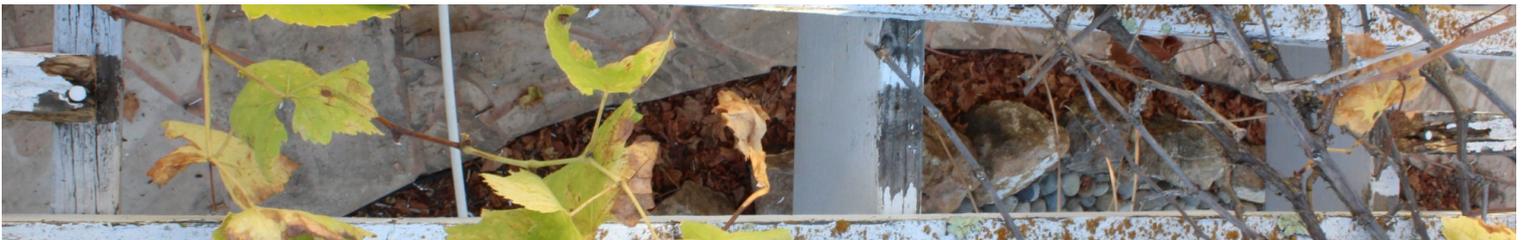
2" x 2" Rod Decayed by Rain

Cut & Removed Rod between Three Joists (2" x 6") Distance (44" + 2" Length)
