Repair Washer

Maytag Neptune does not spin when dry spin cycle. This is widely known problem that Maytag had to recall.

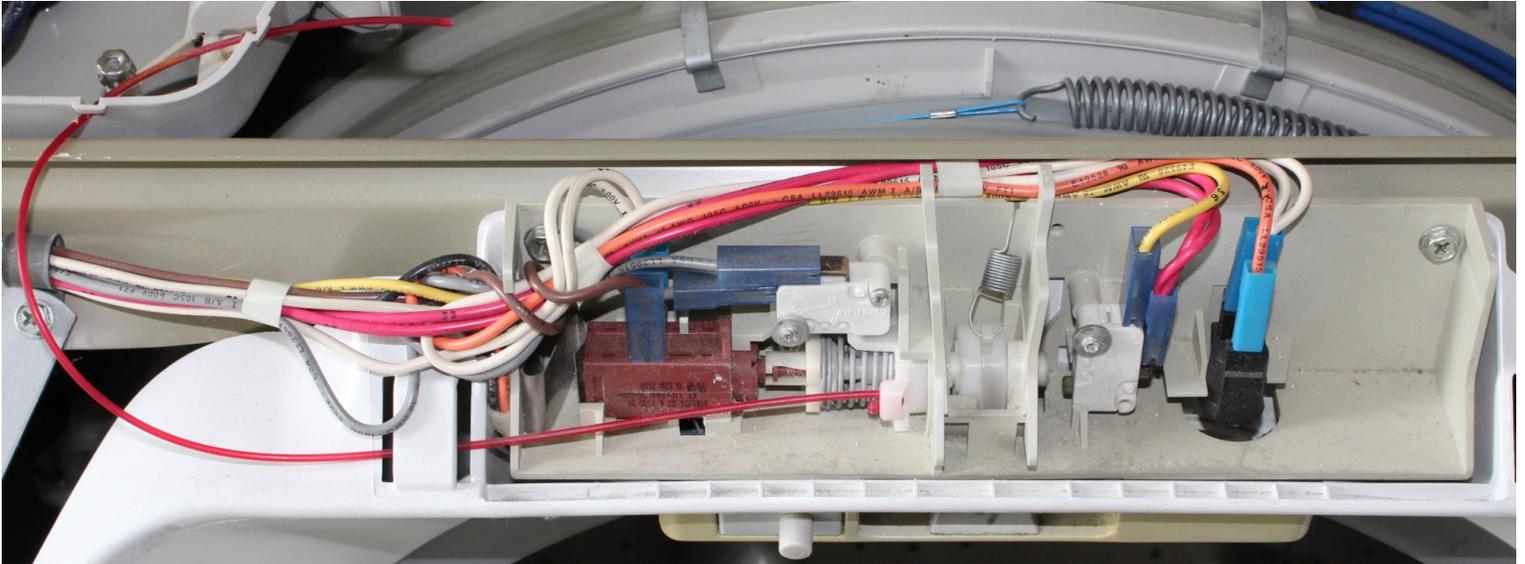
Malfunctioned Wax Motor (Brown Shaft), Micro Switches, etc.

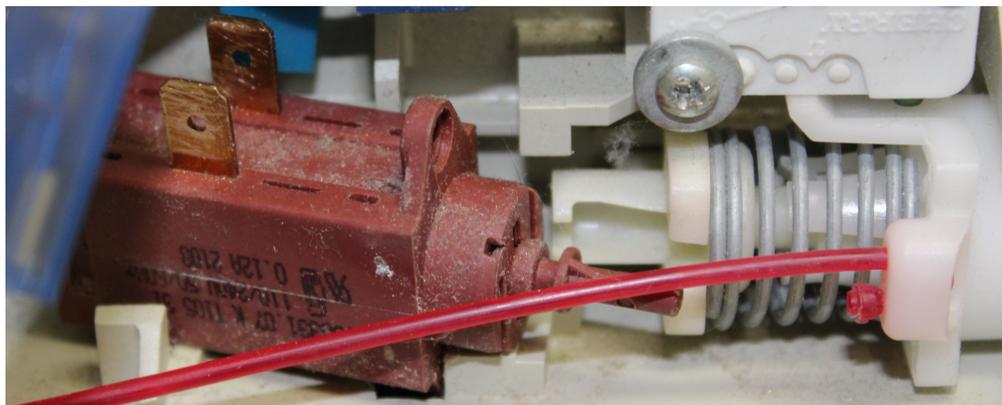
Removing Malfunctioned Wax Motor (Brown Shaft)

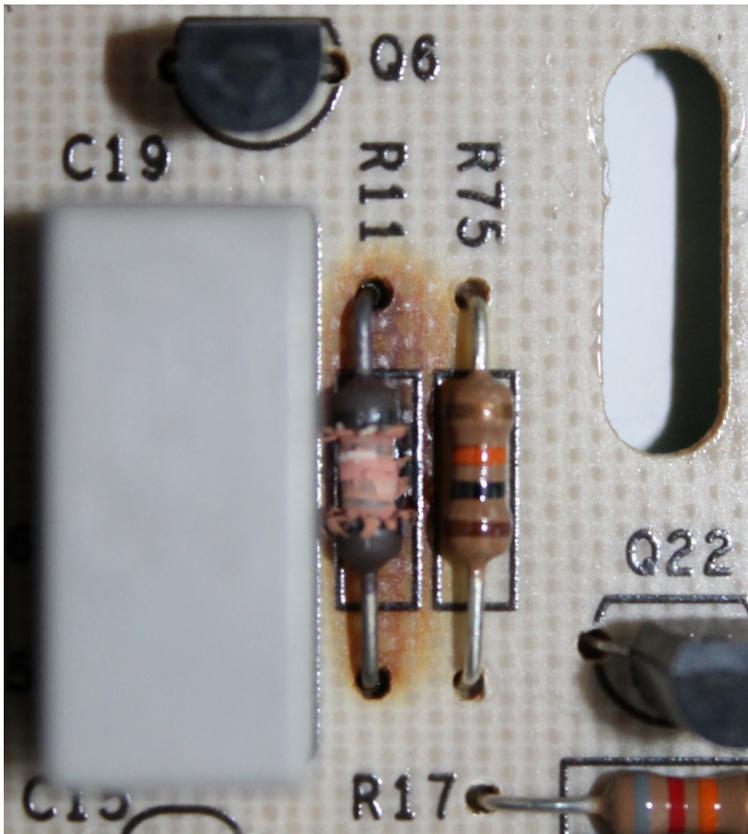
Parts Side View (Burnt R11 (5 kΩ), Q6 (Triac) Intact)

R11 (5 kΩ) connected to gate input of Q6 (NTE5655 Triac) which control switching AC 120V was burnt due to large current flow (Initial design problem concerning maximum dissipated power rating of the resistor).

I put two 10 kΩ resistors in parallel to achieve maximum dissipated power rating twice.
