## 2007 Pontiac Vibe Strut Boot Replacement

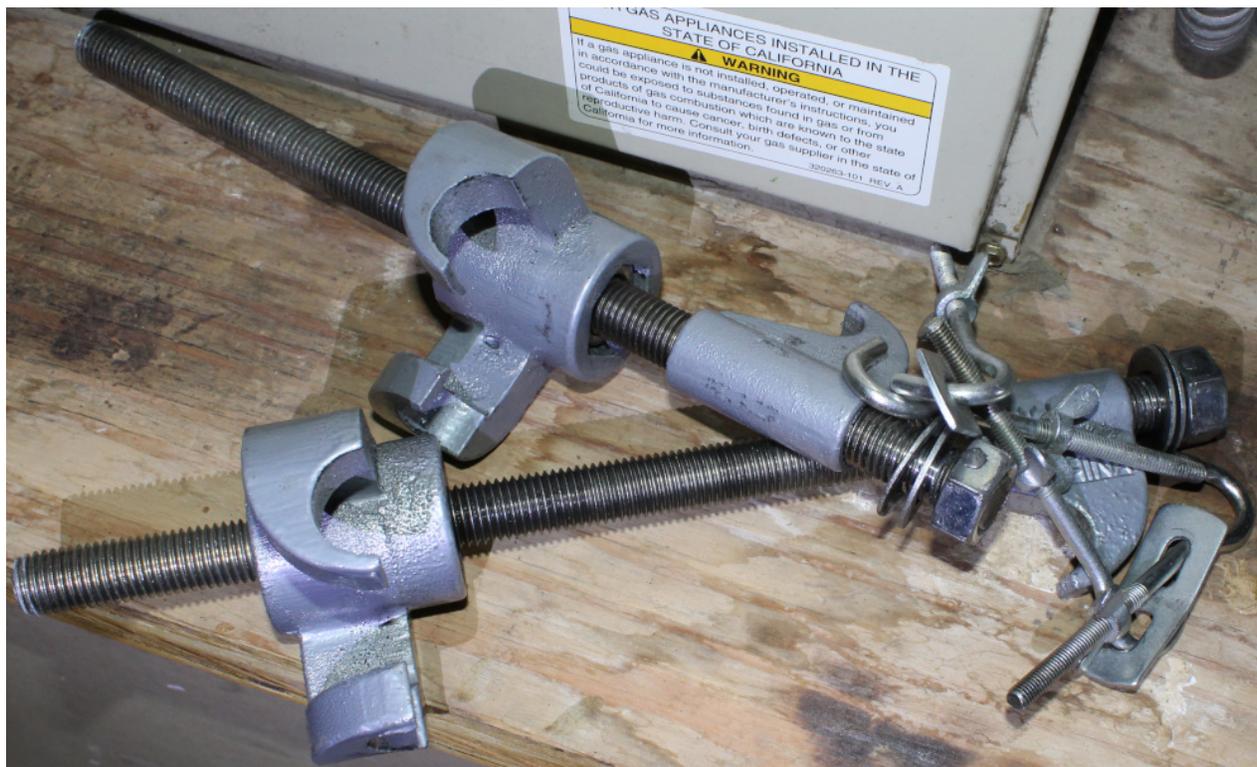
MacPherson Strut Spring Compressor

This tool is indispensable.

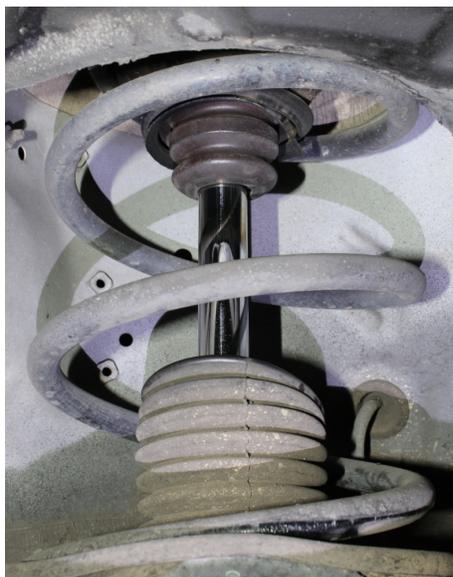
Strut Boot Ripped Down

Because strut boot ripped down, bump stop (upper) and the chrome shaft of strut had been exposed.

Getting rust incurs strut function deterioration.

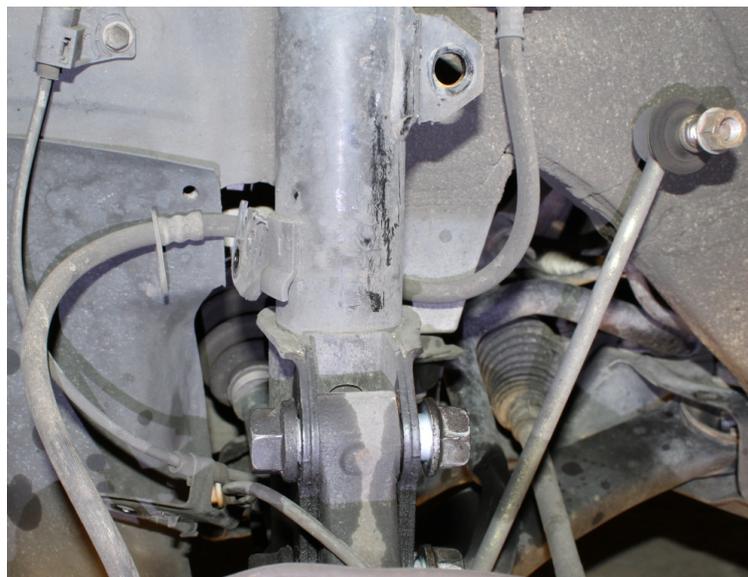
Removing

Tire, break fluid hose, stabilizer bar link, and two knuckle bolts must be loosened and detached.

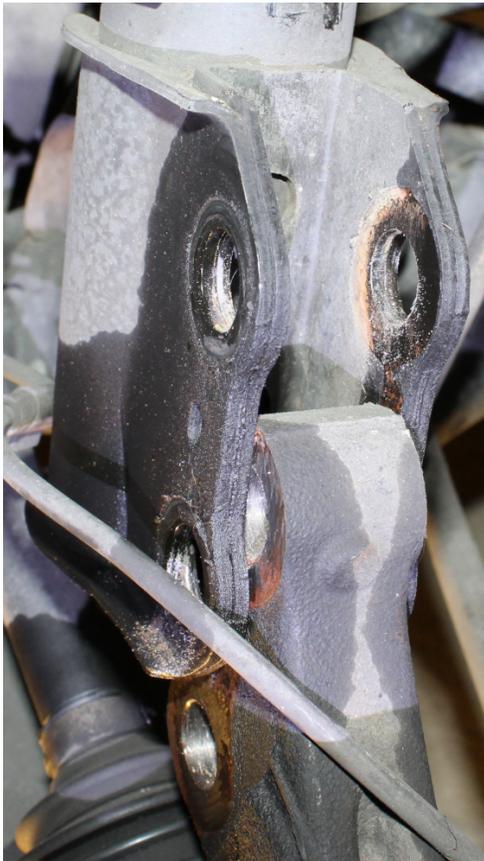
Two Knuckle Bolts Removed

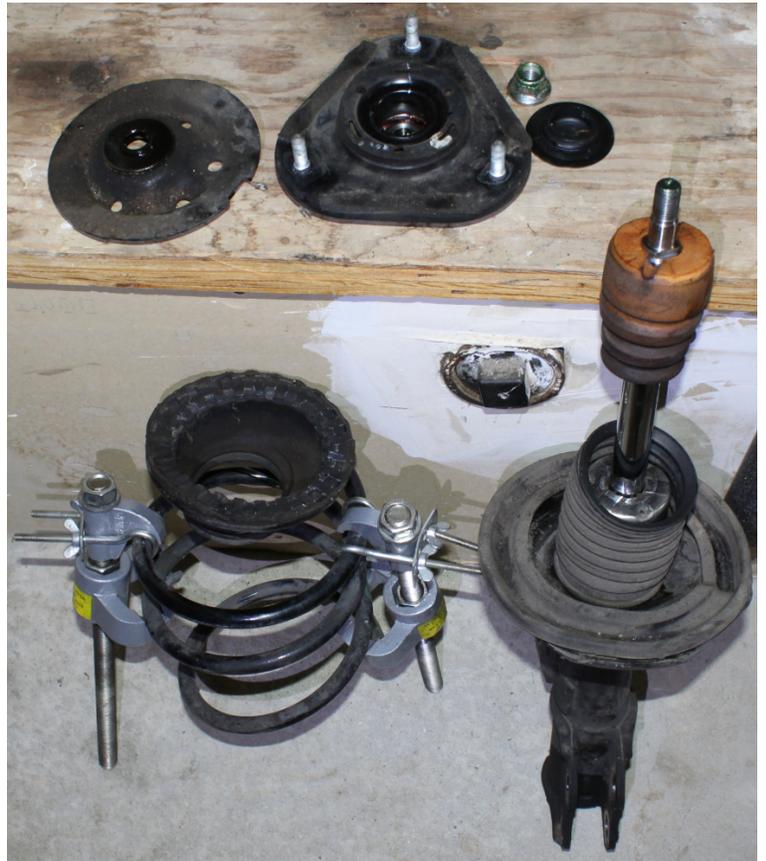
Strut Spring etc. Removed Apart

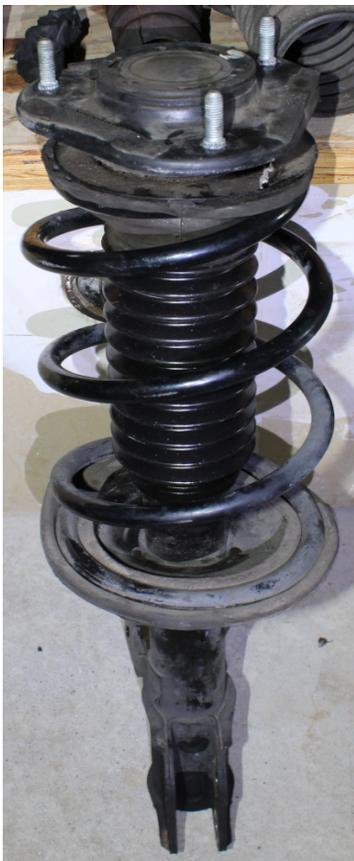
Assembled with New Boot, Dump Stop & Spring

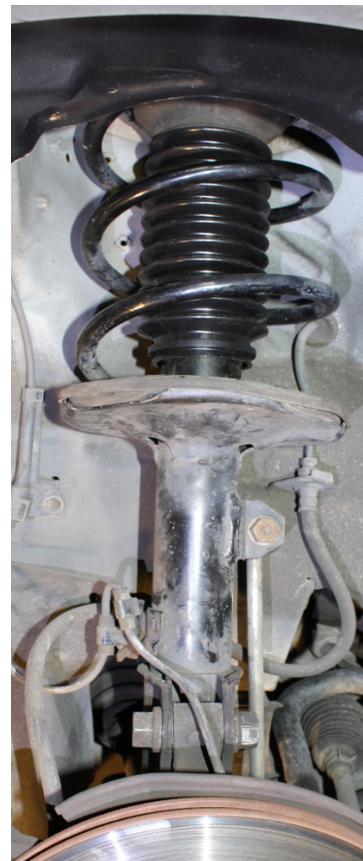
Replaced

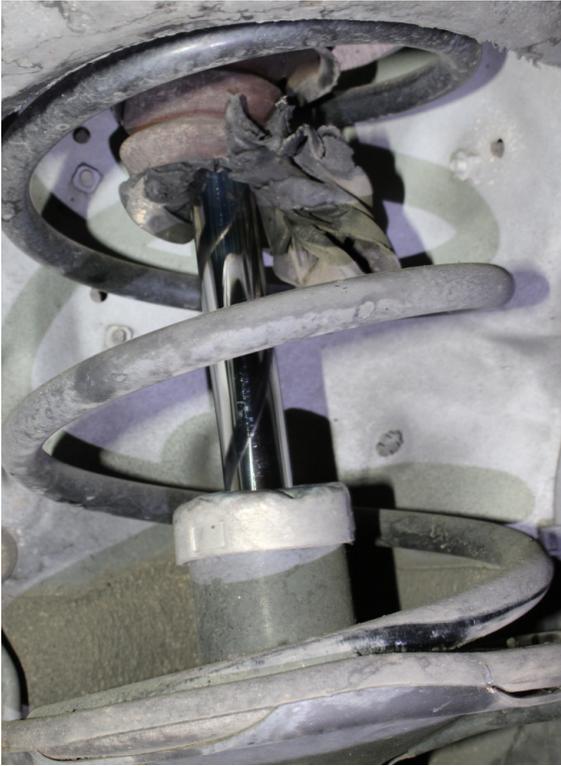
Strut Boot Squashed

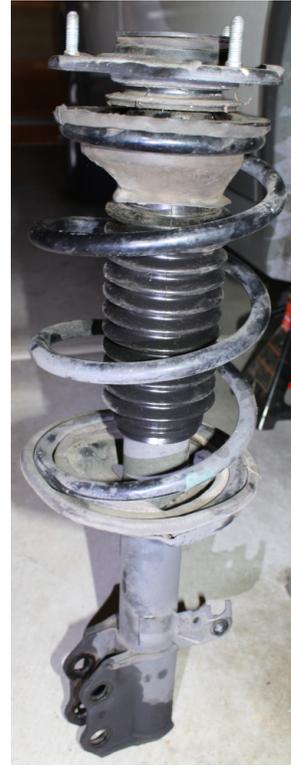
Assembled with New Boot, Dump Stop & Spring

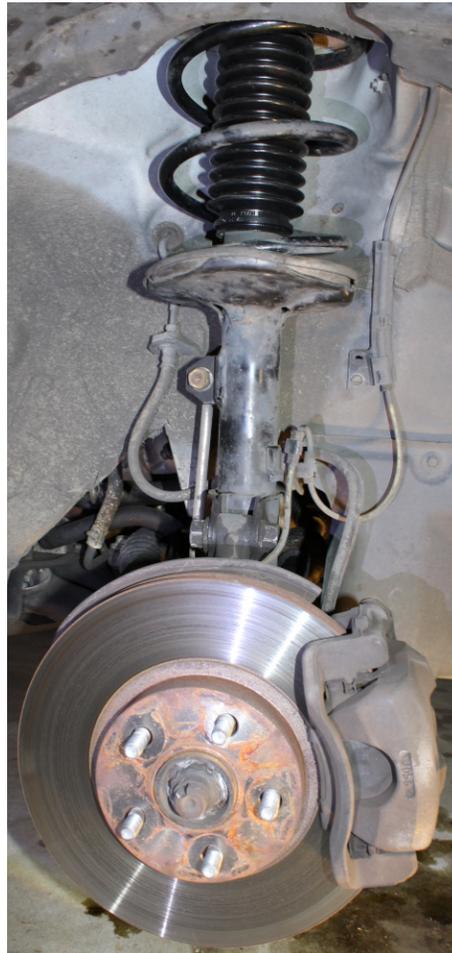
Replaced
