## 1993 Mercury Sable Wagon Engine Mount Replacement

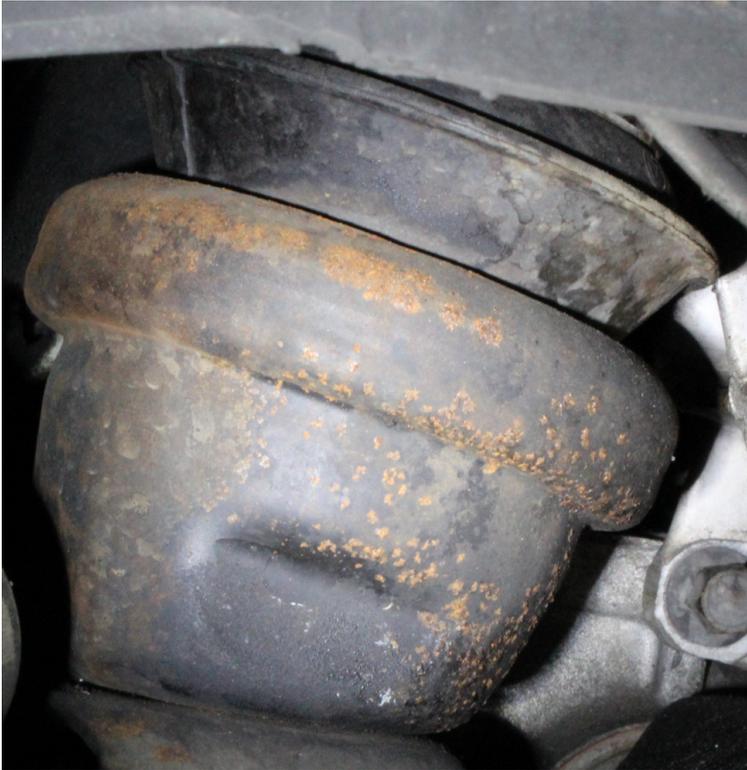
Old Engine Mount

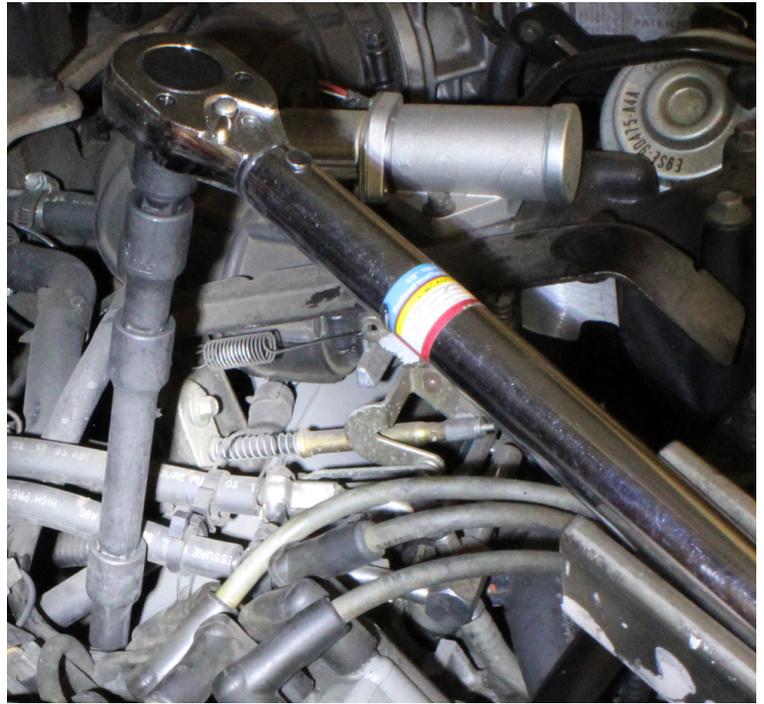
Releasing Engine Mount Nut from Engine Room

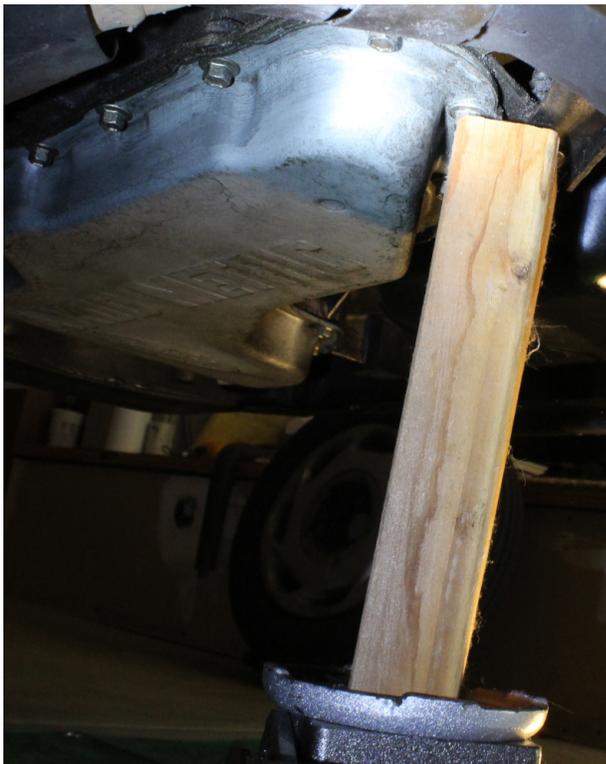
Pushing up the Engine through Oil Pan

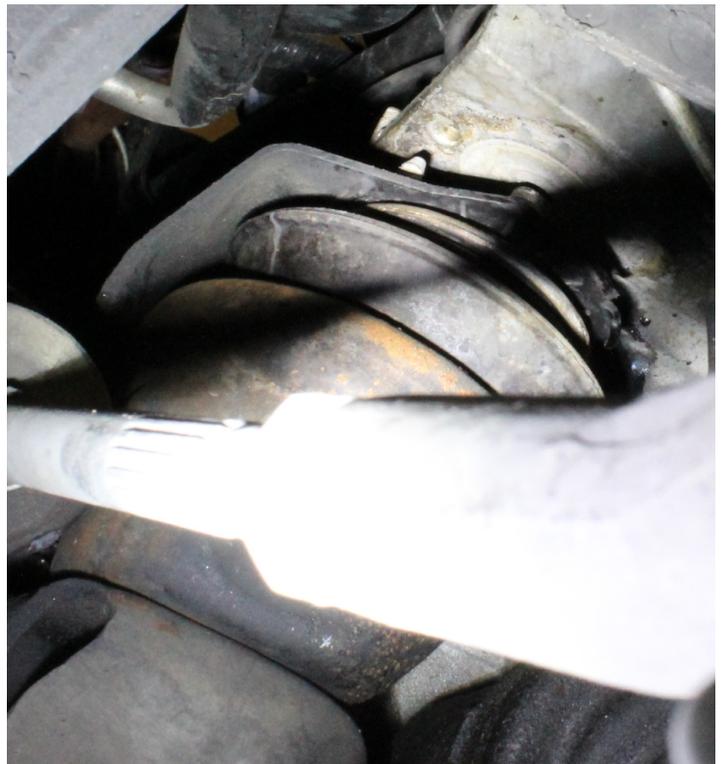
Top of the Engine Mount Released from Engine Chassis

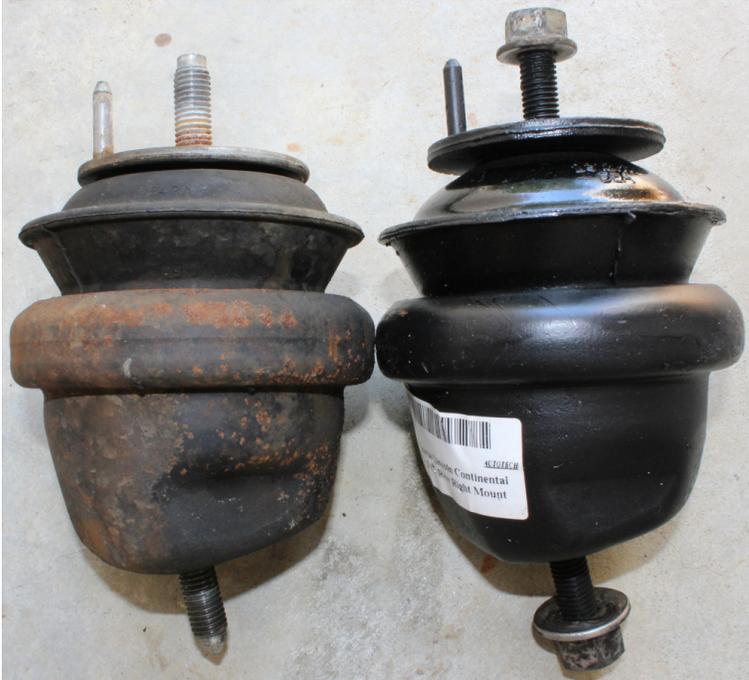
Old & New Engine Mount

Rubber cushion of old engine mount got deteriorated and the height is lower than new engine mount.

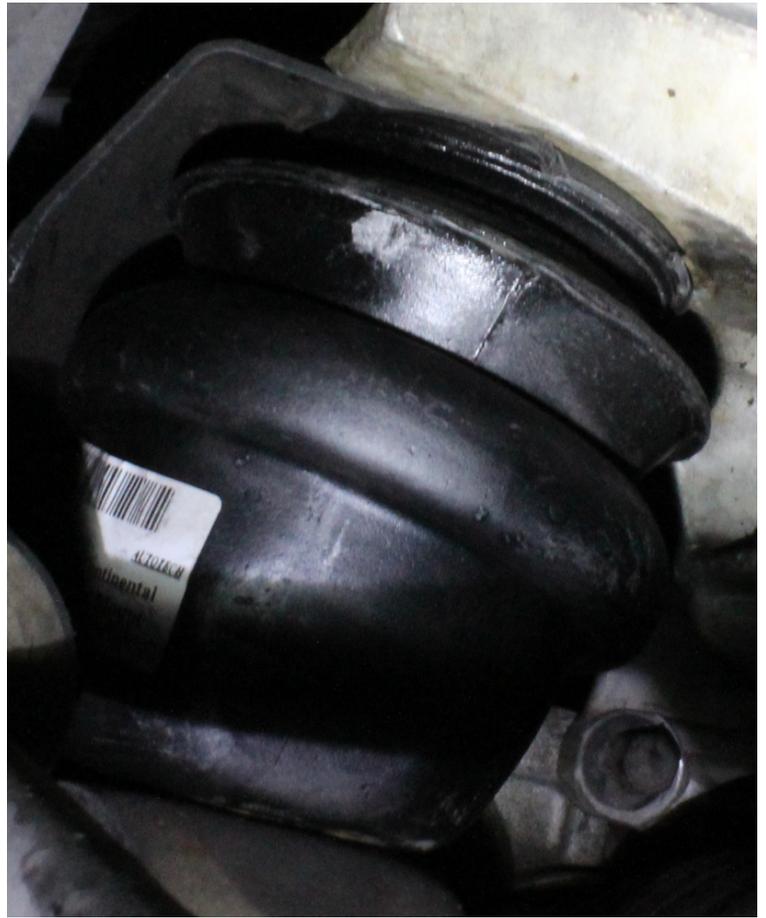
Replaced
