1995 Toyota Camry Air Intake Tube Replacement

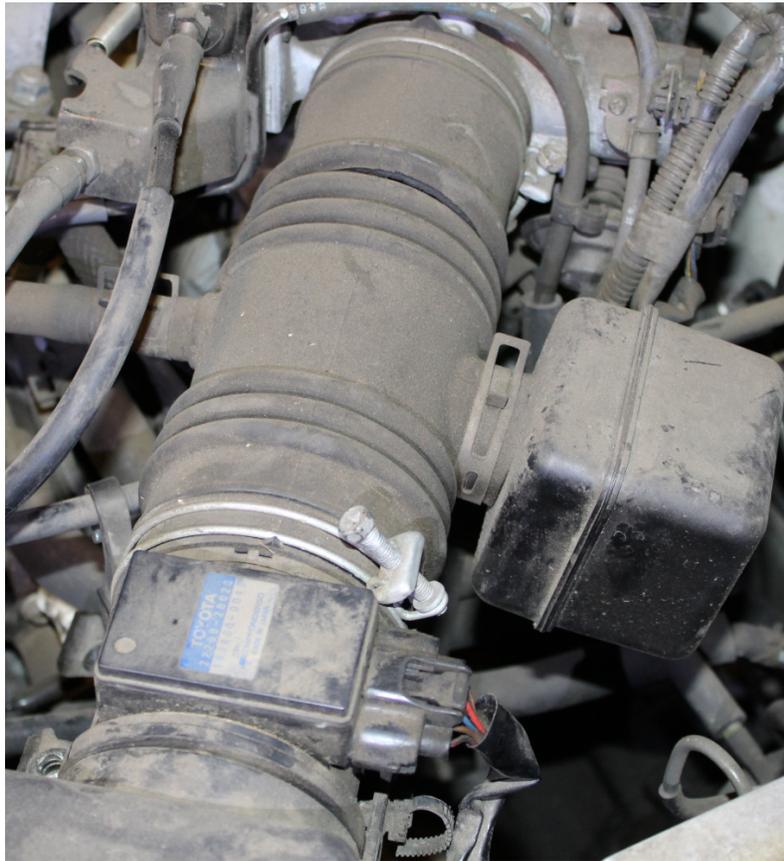
Before Replacement

Big Crack of Tube

OBDII scanner exhibits P0101, Mass air flow sensor measured excessive air intake (out of specified range).

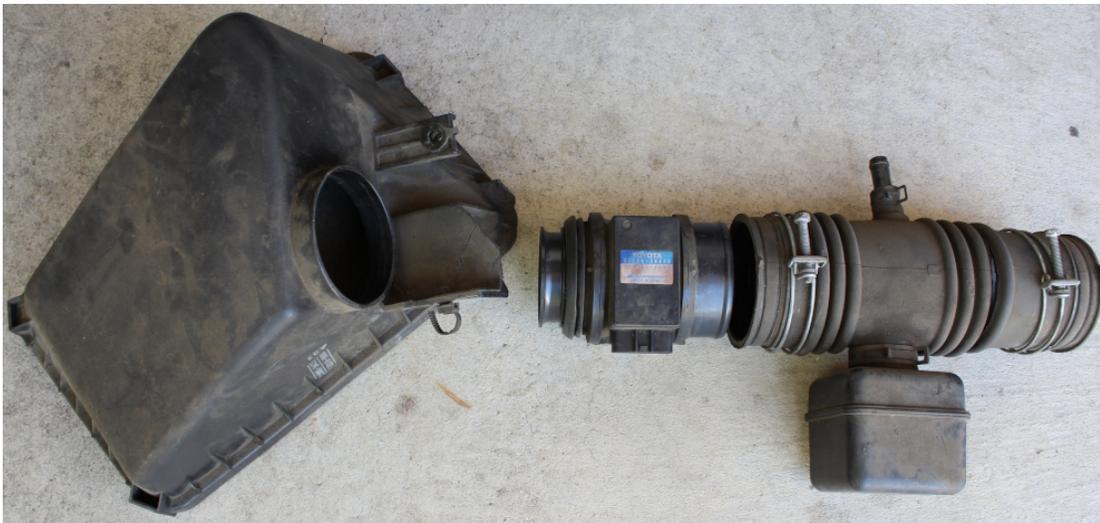
Mass air flow sensor itself is working well (No need to replace).

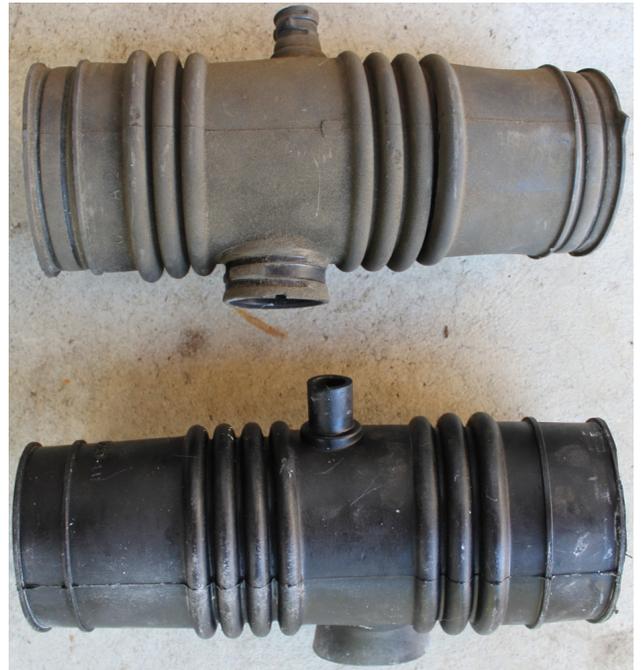
Old (Top) & New (Bottom) Air Intake Tube

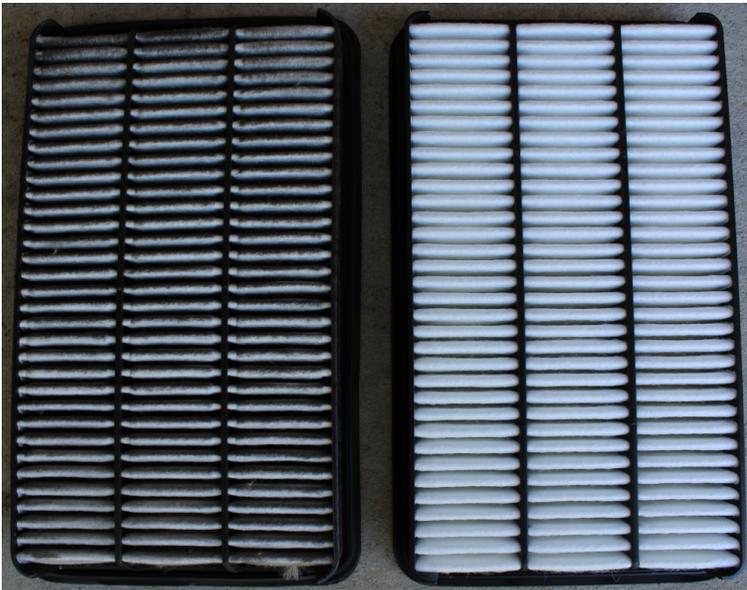
Old & New Air Filter

Because air filter is next to air intake tube to be replaced, the air filter was replaced as well.

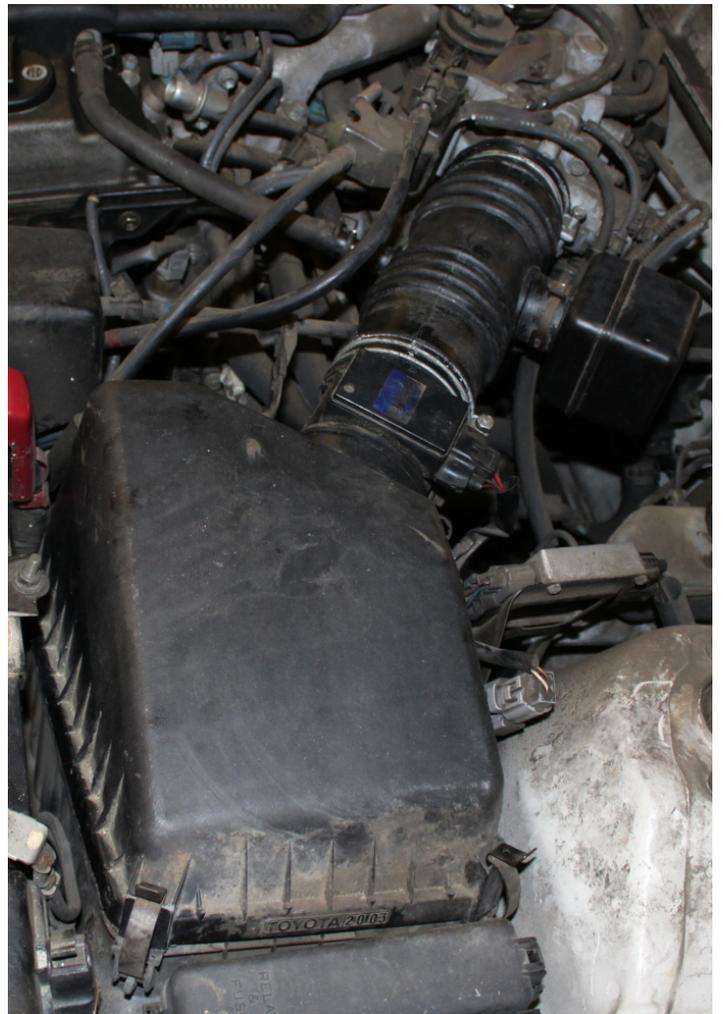
Replaced Air Filter (Bottom) & Tube (Center Right)
