1995 Toyota Camry Drive Axle & CV Joint Replacement

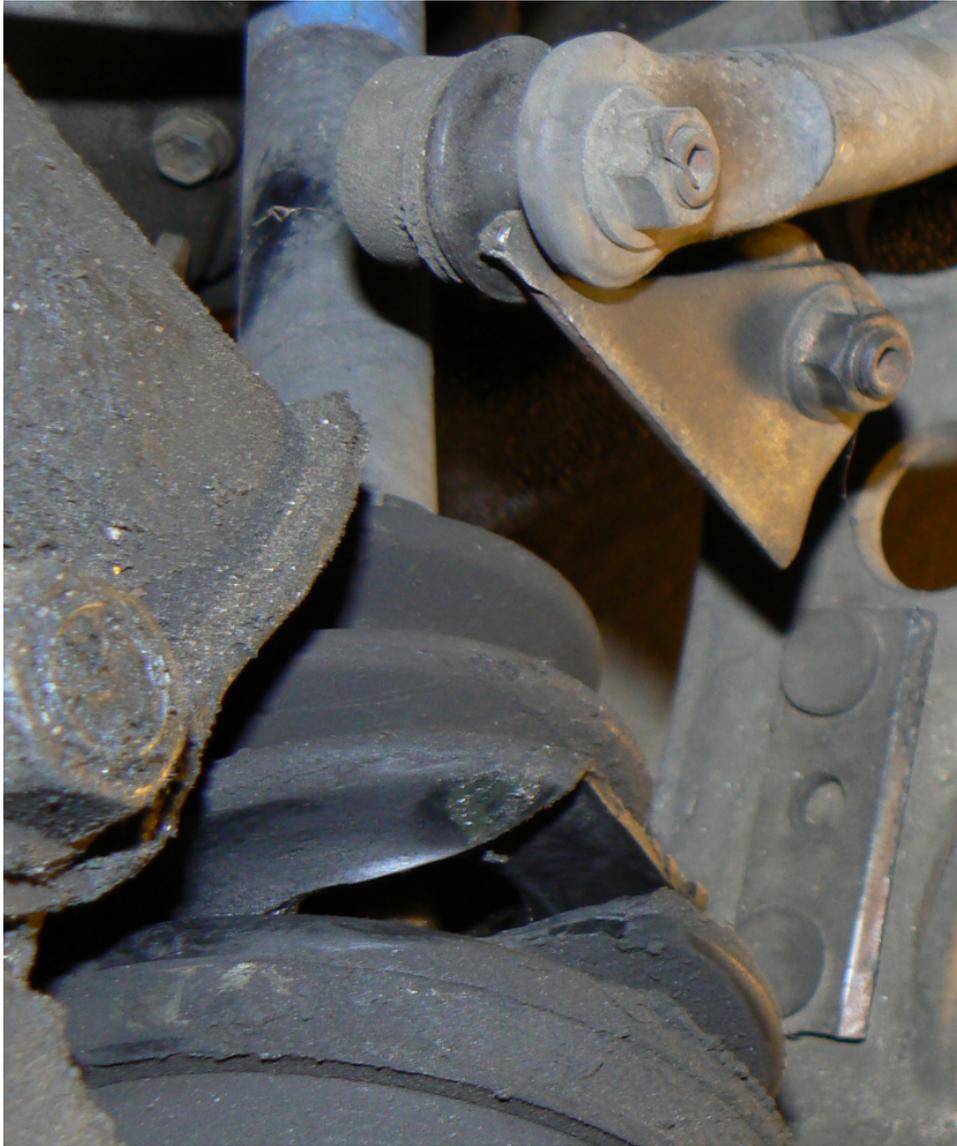
Broken Stabilizer Link Set Bracket (Right) & Broken CV Joint Sleeve (Bottom)

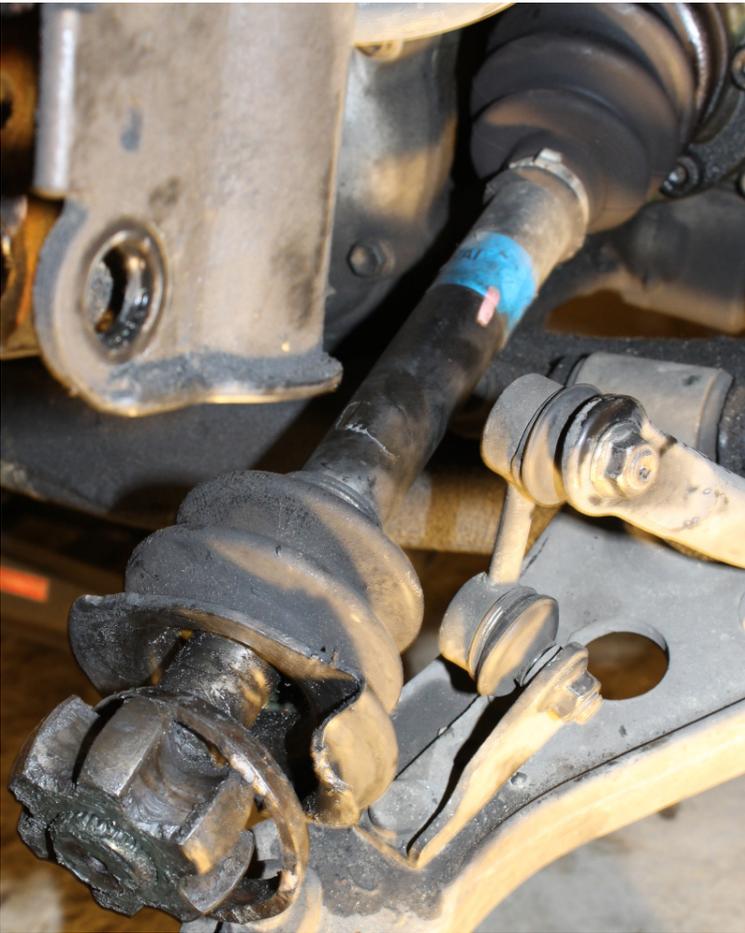
Broken CV Joint & Replaced Stabilizer Link Set Bracket

When CV (Constant Velocity) joint broke, stabilizer link set bracket broke at the same time. Six big and heavy metal balls in CV Joint fell down and scattered on the street.

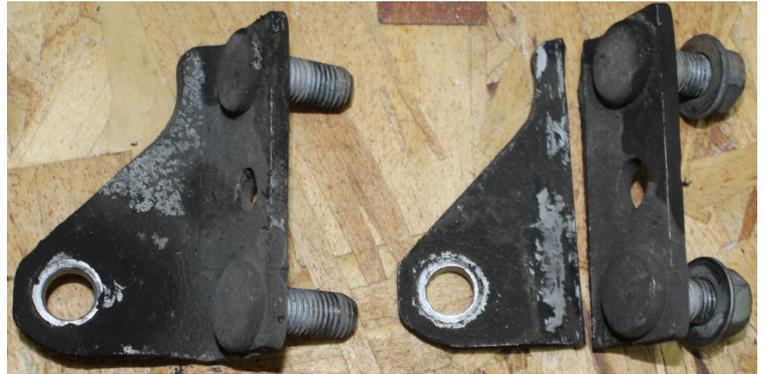
Working Stabilizer Link Set Bracket & Old (Broken)

A working stabilizer link set bracket was taken out from old Camry at junk yard for free.

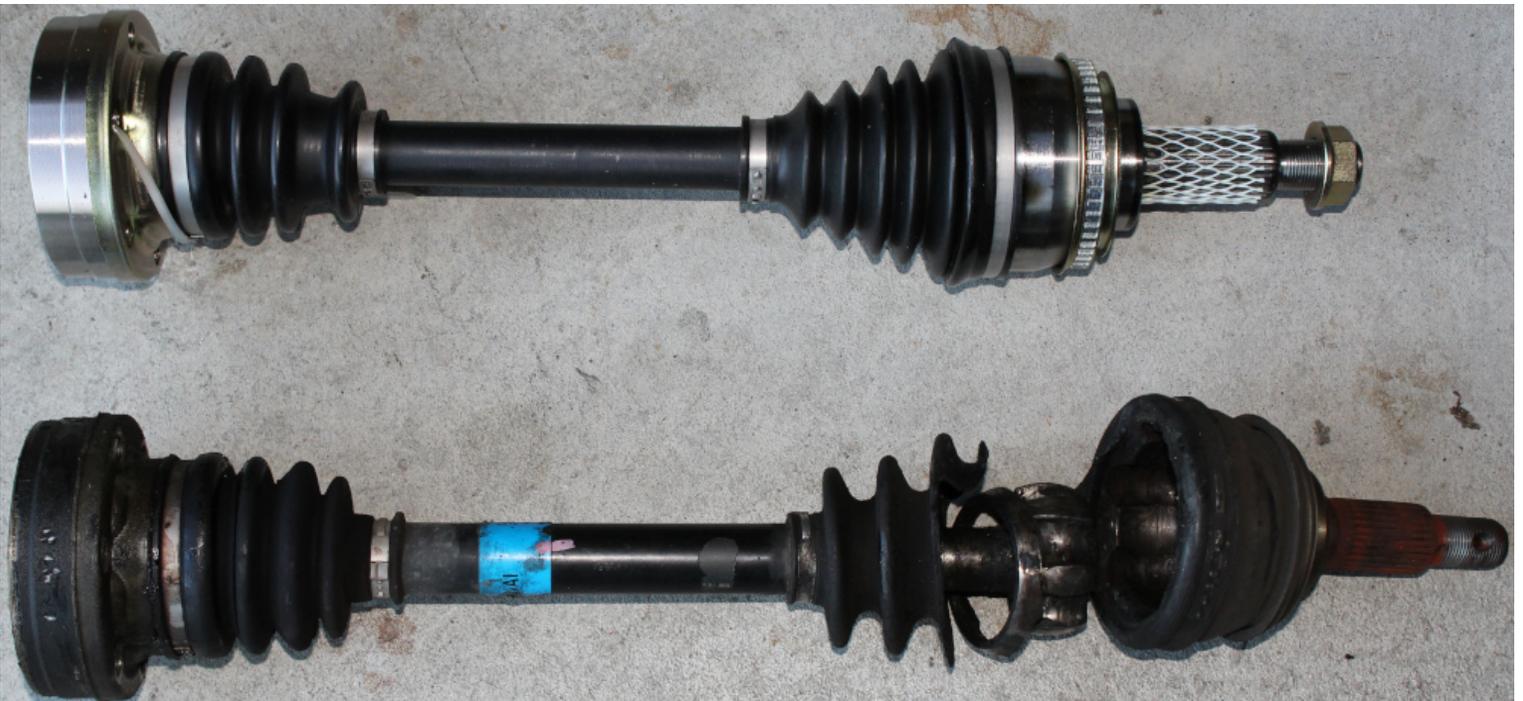
New Drive Axle with CV Joint (Top) & Old Drive Axle with Broken CV Joint (Bottom)

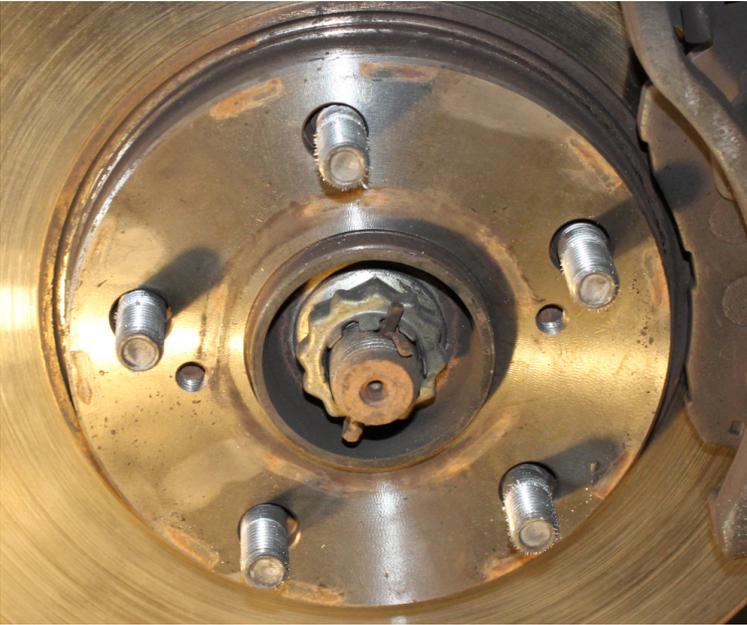
Drive Shaft Lock Nut (Center)

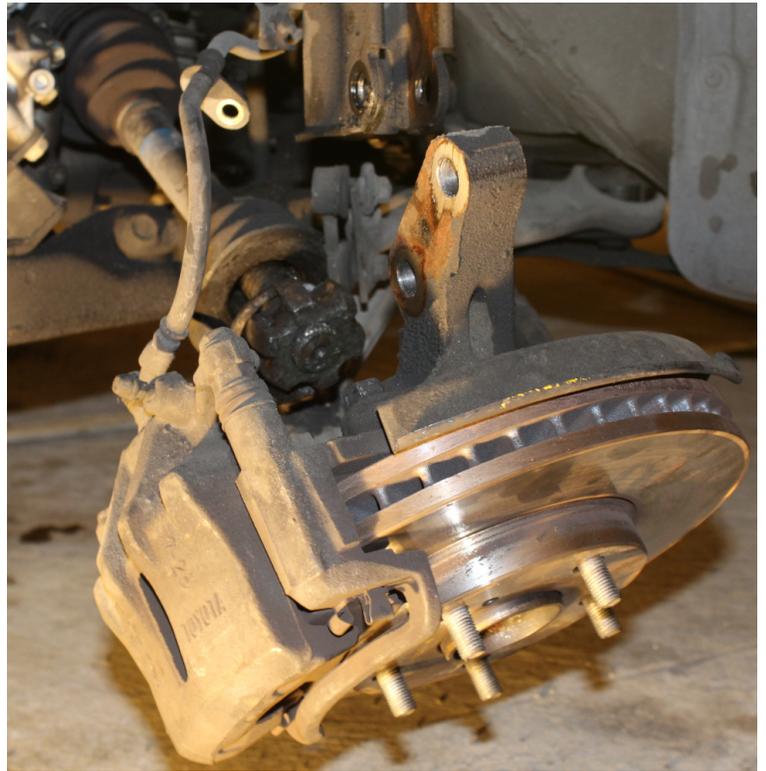
Detached

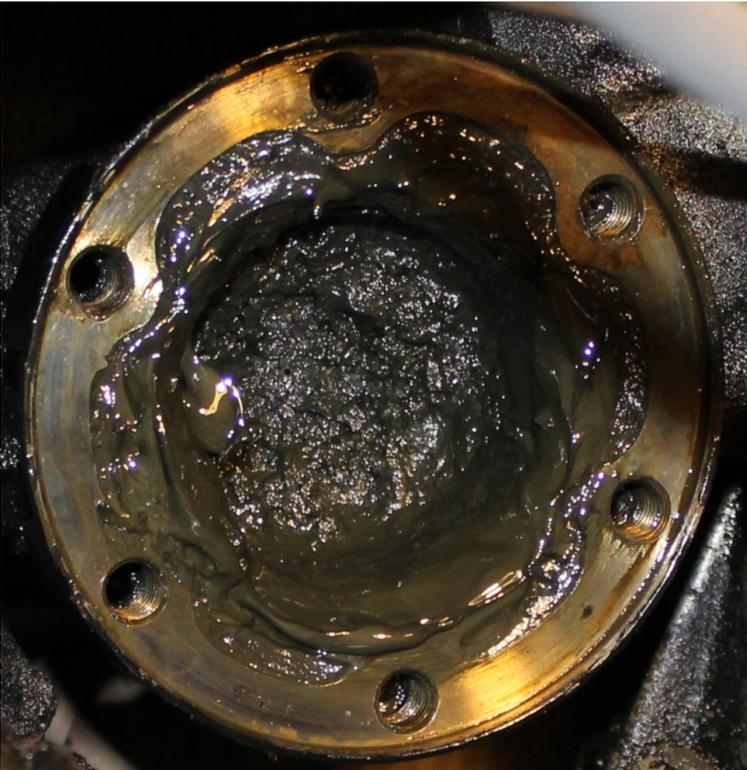
Inboard Joint Sub-Assembly
