1999 Toyota Avalon Gas Lid Hinge Repair

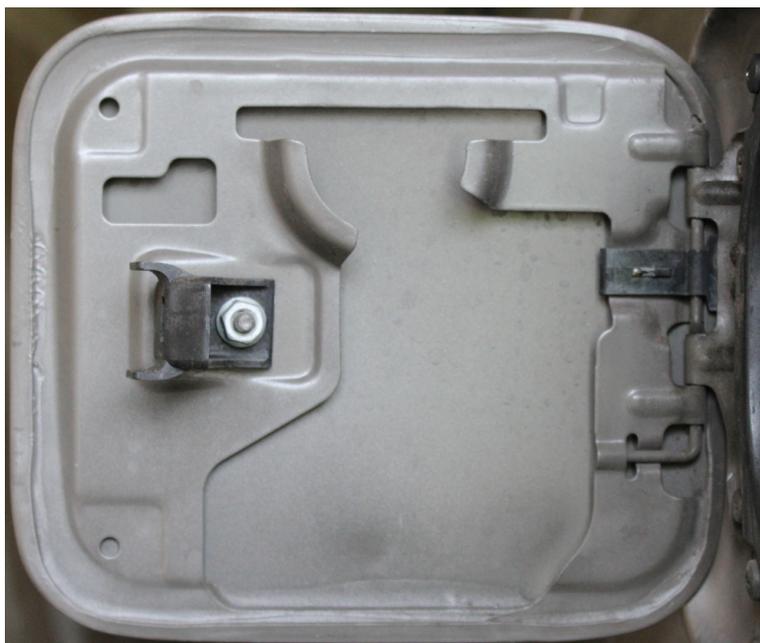
Gas Lid Hinge Flaked Away (Black metal basement shown at right center)

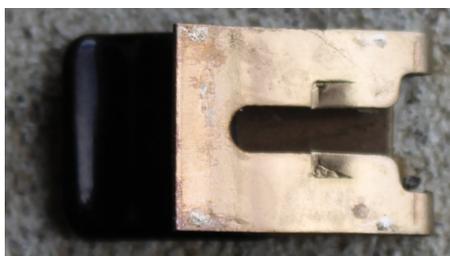
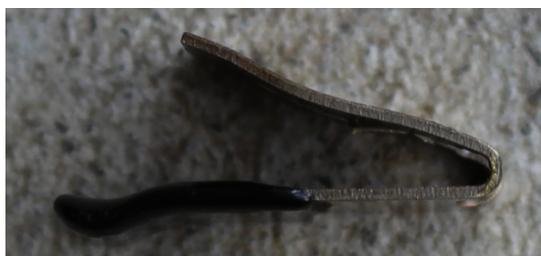
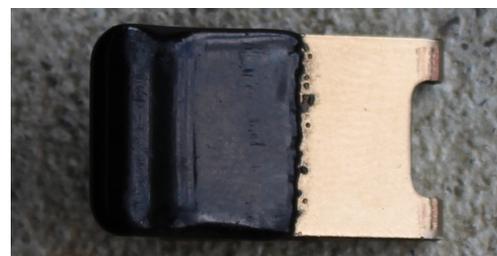
Gas Lid Hinge

The purpose of gas lid hinge is to open the gas lid sufficiently. Because the hinge flaked away from the basement, the gas lid became not opened (not popped up) sufficiently.

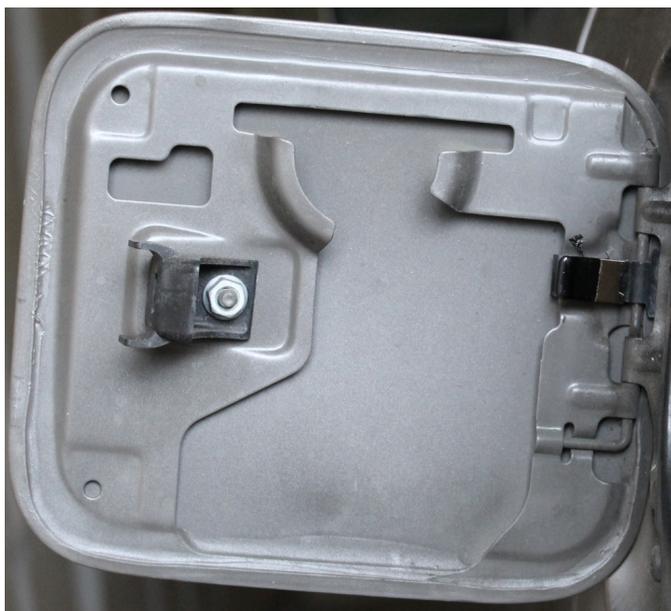
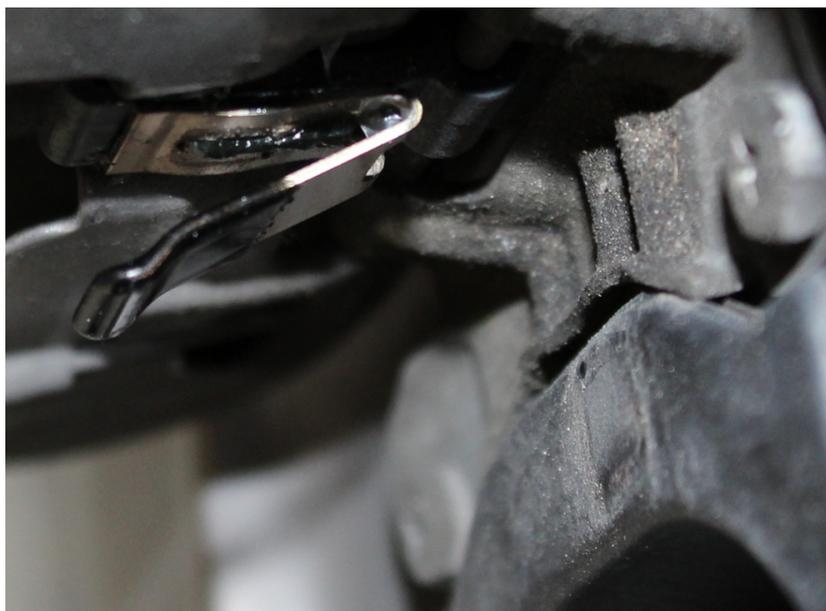
Hinge Pasted

3 years later, the hinge pasted was detached and lost due to deterioration of adhesive.

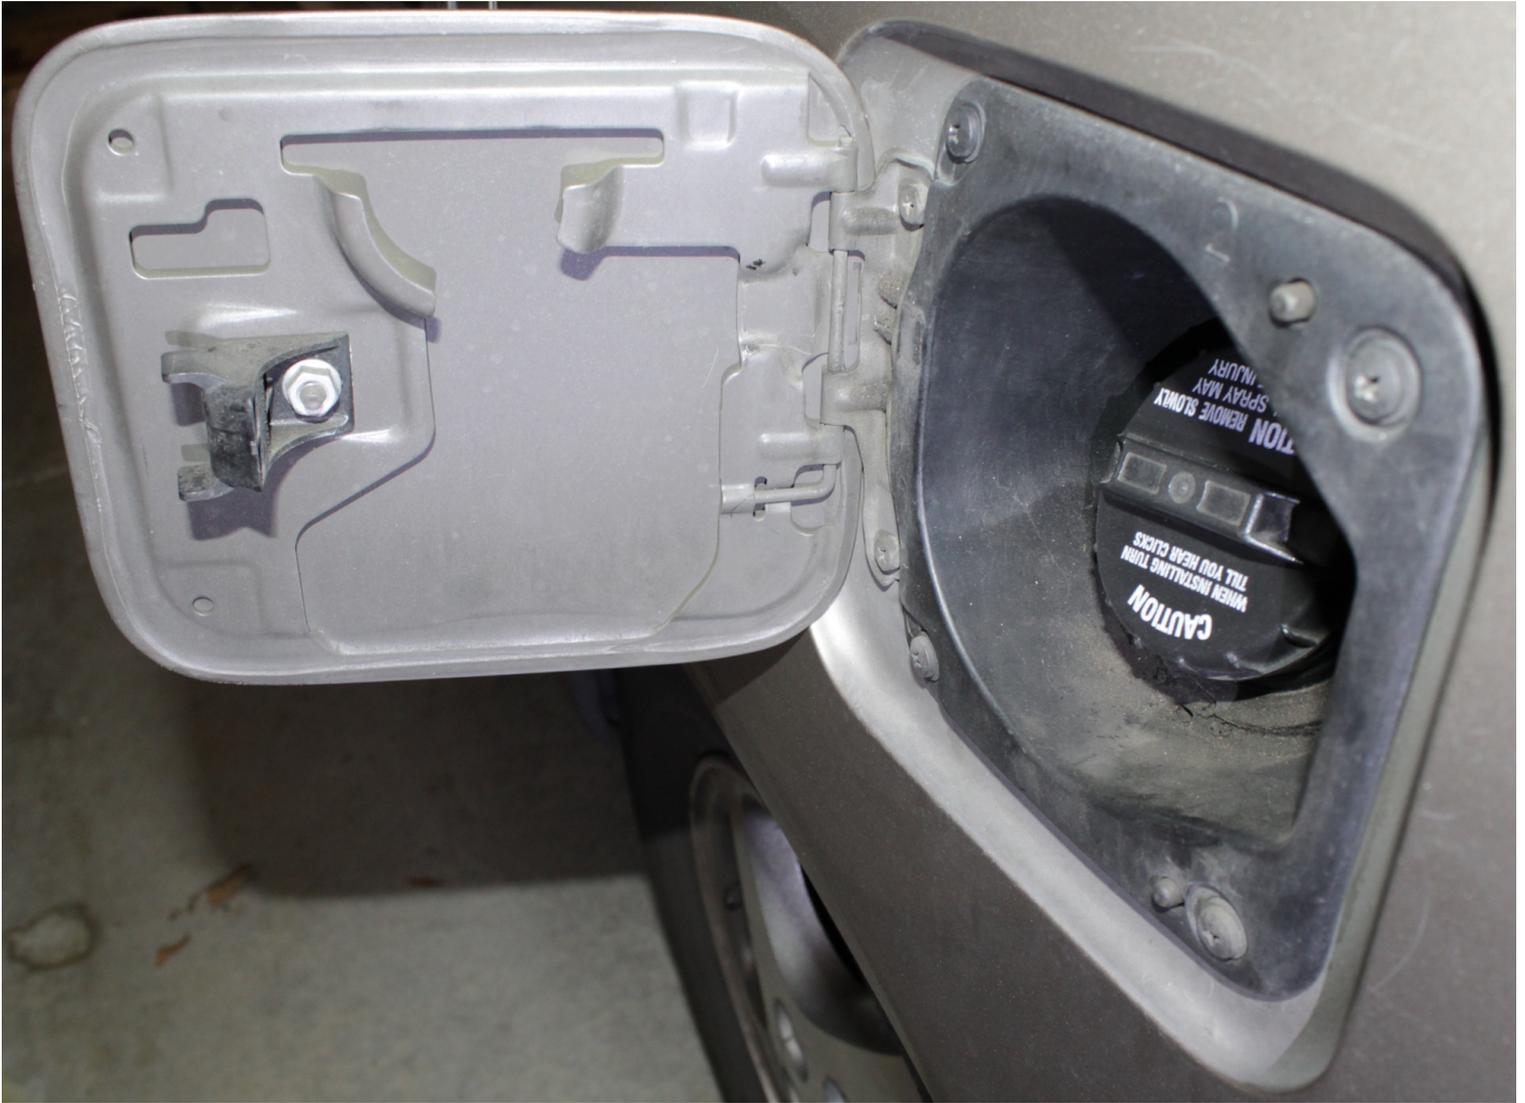
Hinge had gone

No hinge is fatal. It incurs inability of refilling fuel because the gas lid never opens keeping locked. Normally, the fatal status is recognized at gas station dropping by for refill. I am sorry, it's too late...

Therefore, replacement to new hinge is much better than repair in terms of reliability.

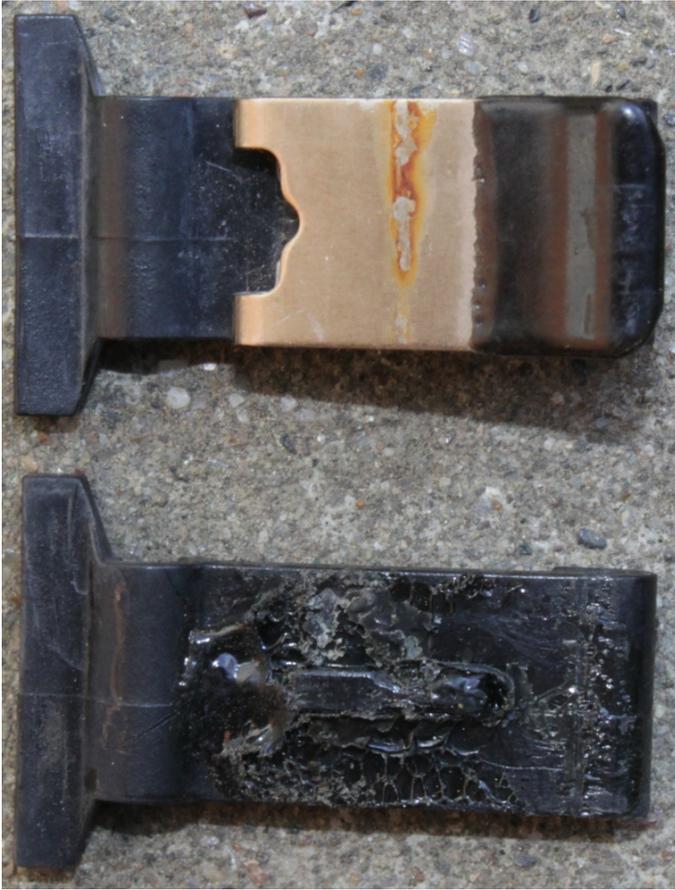
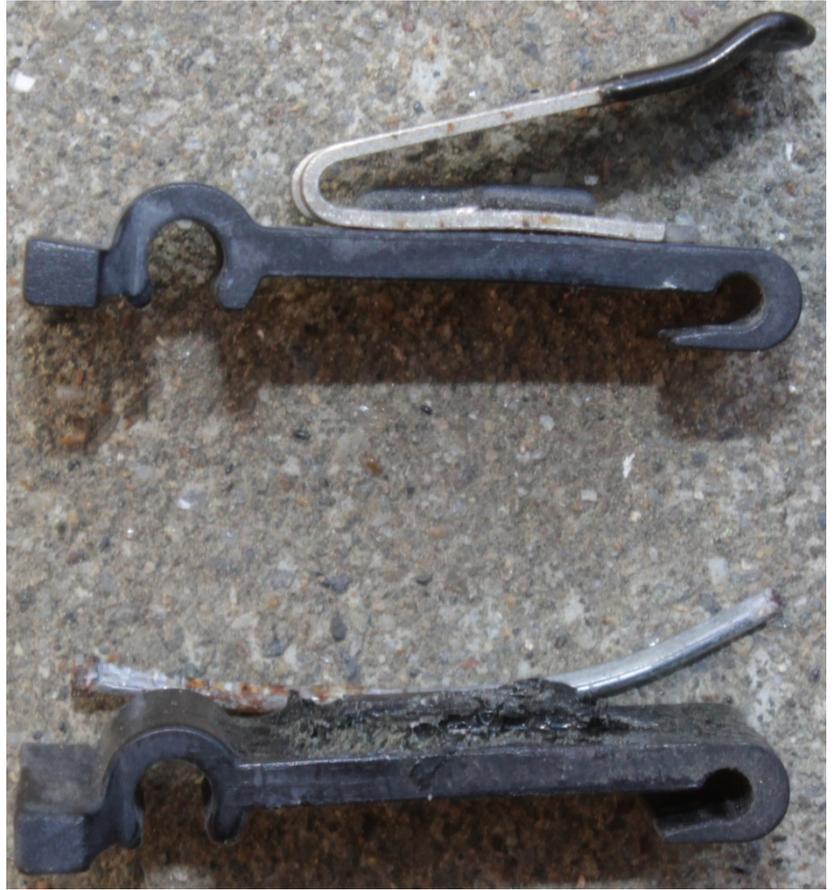
New hinge (Up) & Plastic portion of old metal hinge gone (Down)

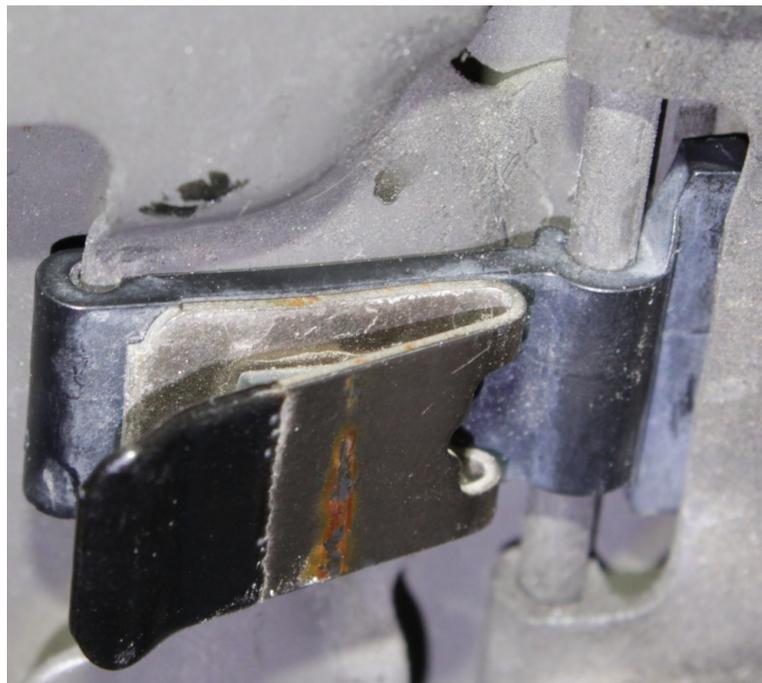
Attached
