µPD7220A (manufactured in 1987 44th week) Encapsulated in Ceramic DIP Package before Decapsulation (µPD7220A was still under mass production even after I designed and resigned from NEC in August, 1987)

Die Photo

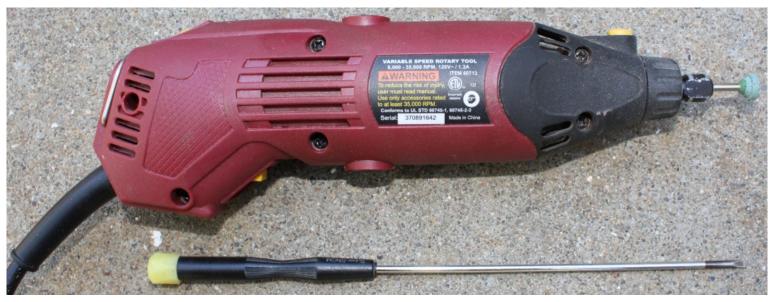
Decapsulation Trial by Torch Failed

Decapsulation by Rotary Tool & Flat Head Precision Screw Driver Succeeded

Slit Made by Rotary Tool (Scorched Cap Due to Torch Trial Failed)

Broaden Slit by Flat Head Screw Driver

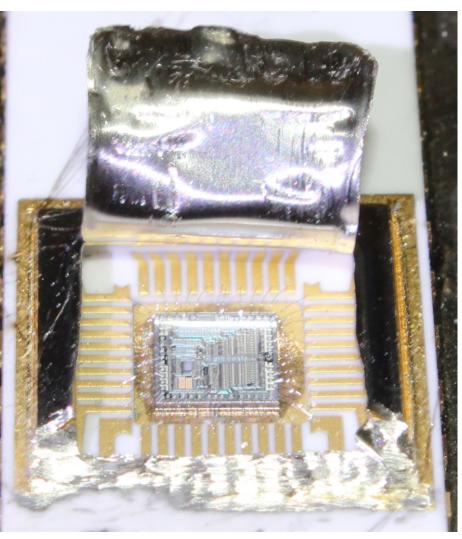
Succeeded (Die & Bonding Wires are all Intact)

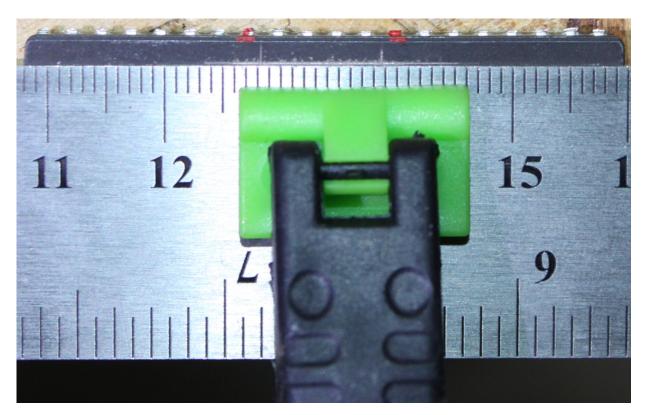
Made Scribe on Four Sides, then Hit Center Punch at Lower Right Corner (Was not exact corner...)

Because center punch position was made at a bit upper of lower right corner, right side got cracked properly but other sides were not. But, the partially failed decapsulation did not affect taking die photos. I was lucky.
