Repair Pendulum Clock

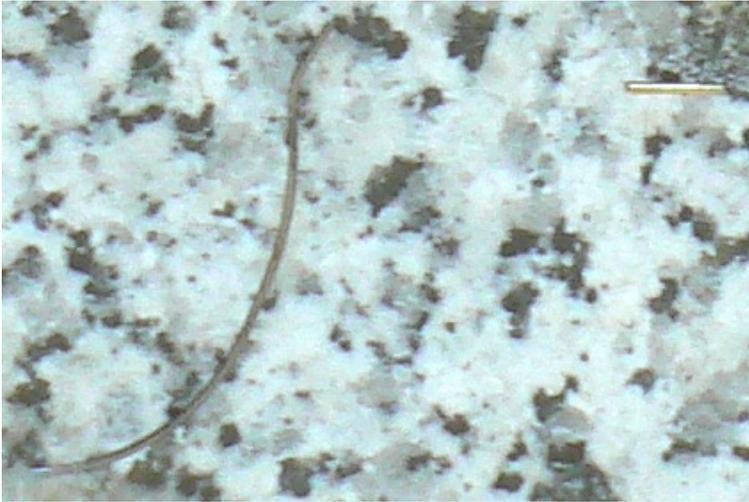
Due to a broken pawl rod for main torsion spring, the ratchet cannot stop the main spring loosened.

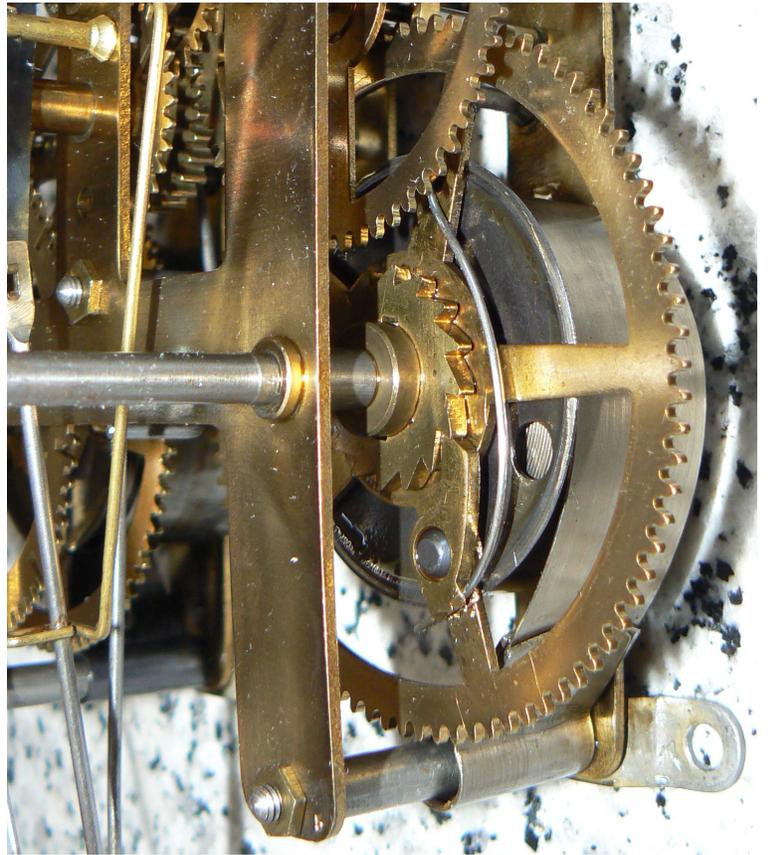
Broken Pawl Rod for Main Spring
