Repair Vacuum Cleaner

Front wheel of Panasonic upright vacuum cleaner is driven by Type UB drive belt. The drive belt must be replaced when pulled apart.

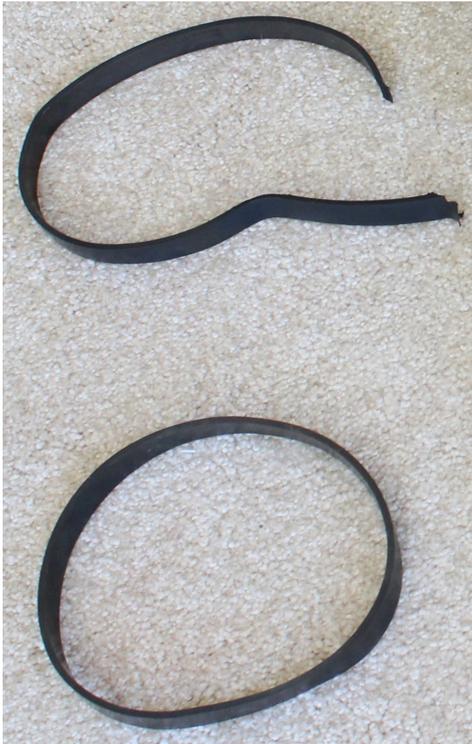
Drive Belt Pulled Apart & New Belt

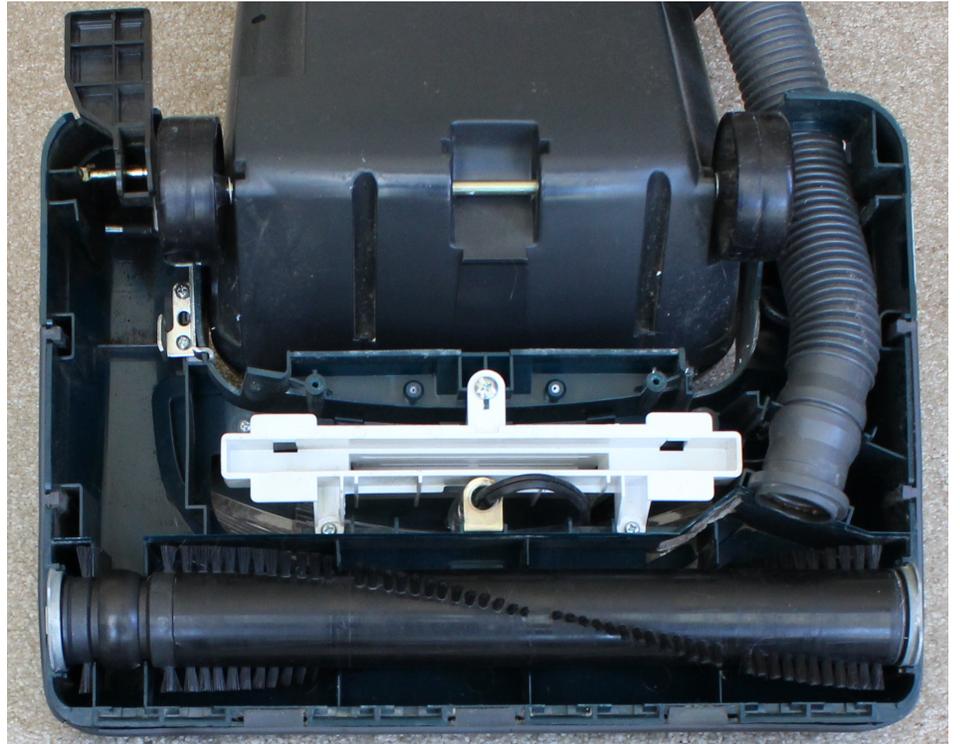
Drive Belt Removed

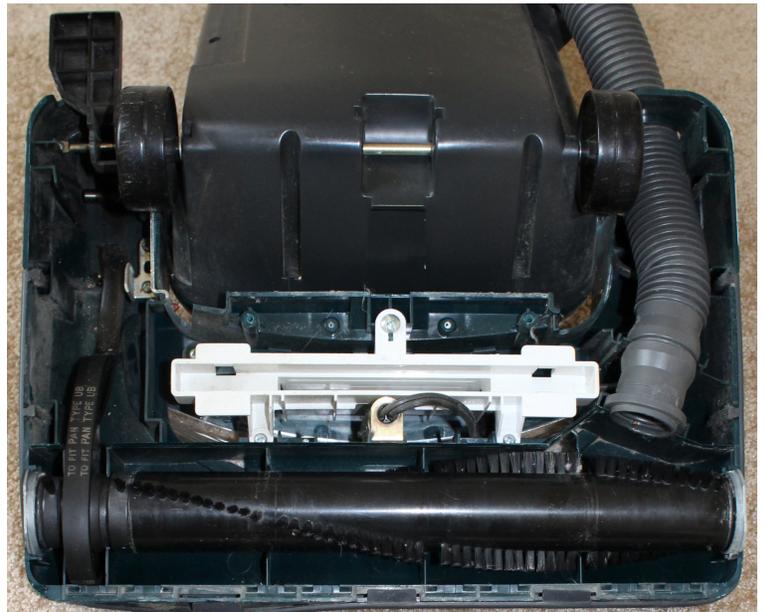
Drive Belt Replaced Pulled Apart 1.5 Year Later Again

Drive belt seems to be fragile.
