1993 Mercury Sable Wagon Front Strut Assembly Replacement

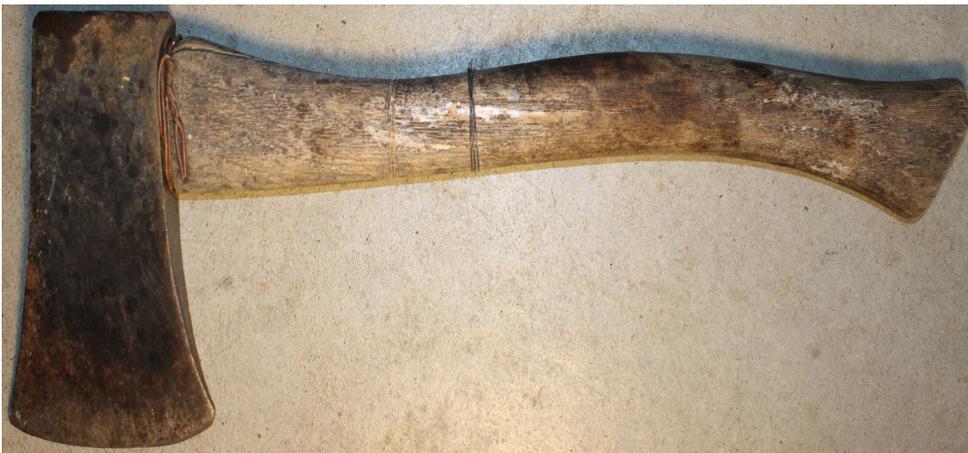
Axe with rectangular back side surface (upper left)

I fastened top three strut assembly mounting nuts to make the strut assembly position higher. Then, I stroke top circular edge of steering buckle down by using axe left and right side alternatively and succeeded to separate the strut assembly from steering buckle rotating and lowering the steering buckle.

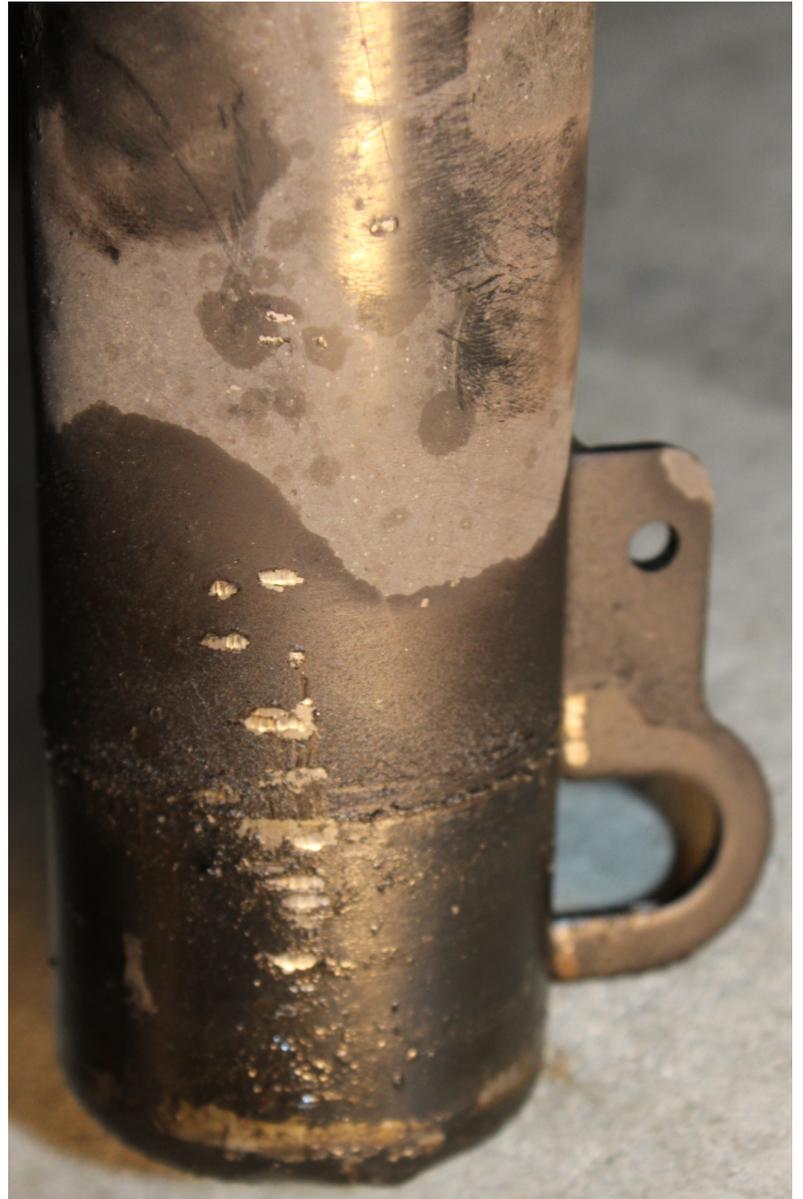
Tab (right) to be inserted in a slit of top steering buckle
