Repair Washer

Maytag Neptune does not spin when dry spin cycle. This is widely known problem that Maytag had to recall.

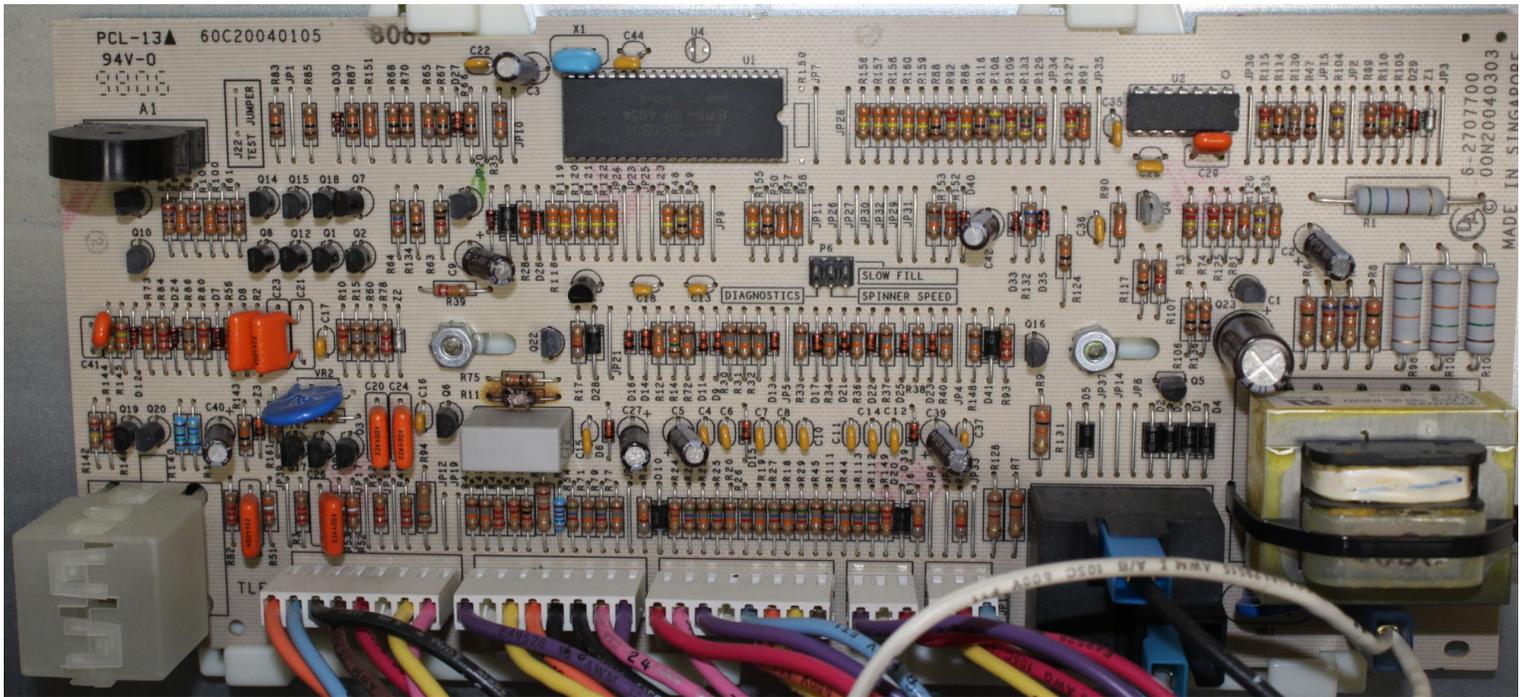
Control Board

R11 (5 kΩ) connected to gate input of Q6 (NTE5655 Triac) which control switching AC 120V was burnt due to large current flow (Initial design problem concerning maximum dissipated power rating of the resistor).

I put two 10 kΩ resistors in parallel to achieve maximum dissipated power rating twice.
